Fraunhofer Institute for Building Physics IBP

IBP report HTB-005EN/2023

Assessment of the long-term reliability of installed external thermal insulation composite systems

Conducted on behalf of
Verband für Dämmsysteme, Putz und Mörtel e.V.
Reinhardtstraße 14
10117 Berlin, Germany

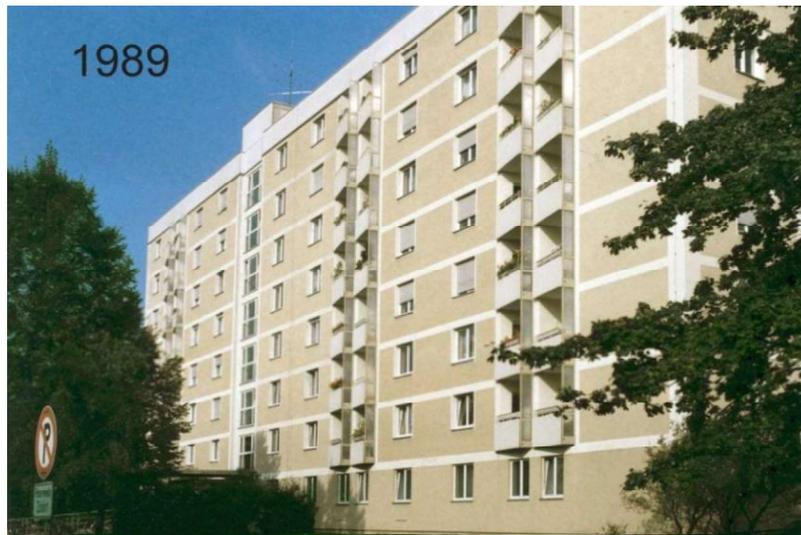
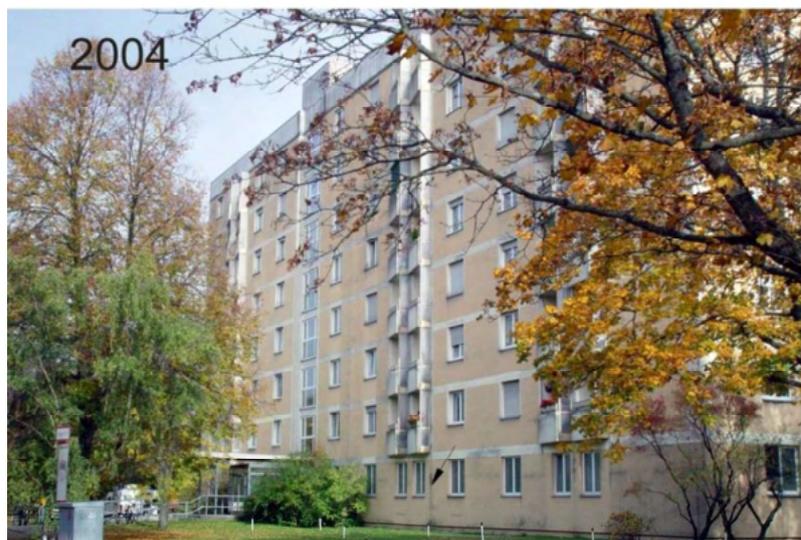
Figure 4 and Figure 5 show the west façade of object 16 (retirement home in Munich). The change in the façade over 33 years can be clearly seen here. The top image shows the façade three years after a 60 mm thick mineral wool insulation was applied (1989). The façade had not been reworked since it was created. In the lower image of Figure 4, some graying and algae formation can already be seen on unprotected wall sections (2004). The upper image of Figure 5 shows the façade condition in 2014, and the lower image shows the condition of the façade today after 33 years. In the meantime, nearly the entire façade has grayed, or the façade color has weathered away. The fastening dowels of the ETIC system are clearly visible (see Figure 6). The high weathering stress on the façade is also indicated by the condition of the balustrades, which show a considerably stronger discoloration than the ETIC system. No significant defects are visible on any of the four façade orientations. No cracks are visible over the surface. This is the oldest assessed building not maintained with functional ETICS, even though it needs renovation from an optical point of view. Overall, the façade has not significantly deteriorated since the last assessment.

Figure 4:
West facade of object 16 (retirement home in Munich) in 1989 (top), in 2004 (bottom). The different color appearances are solely due to the coloring of the photo.

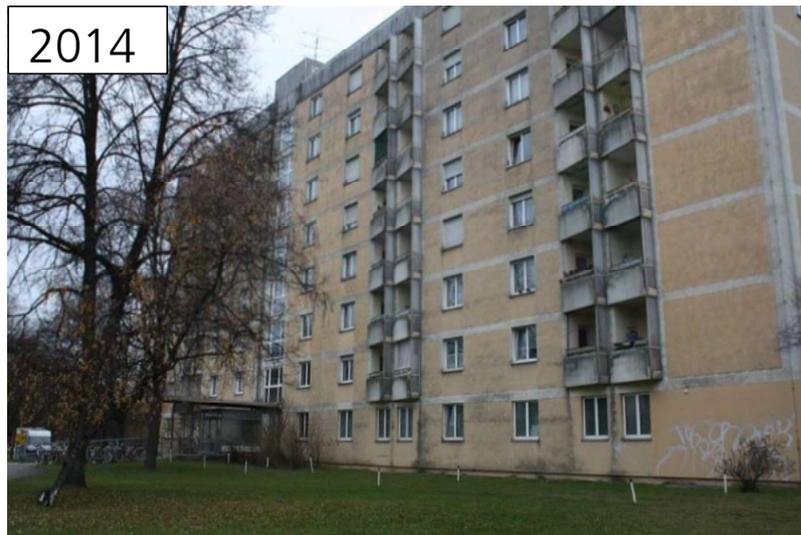
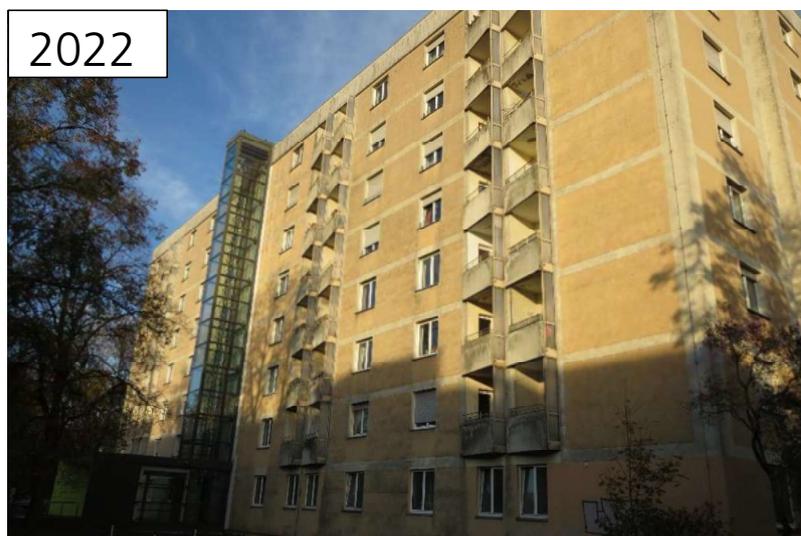
Figure 5:
West facade of object 16 (retirement home in Munich) in 2014 (top), in 2022 (bottom). The different color appearances are solely due to the coloring of the photo (weather).

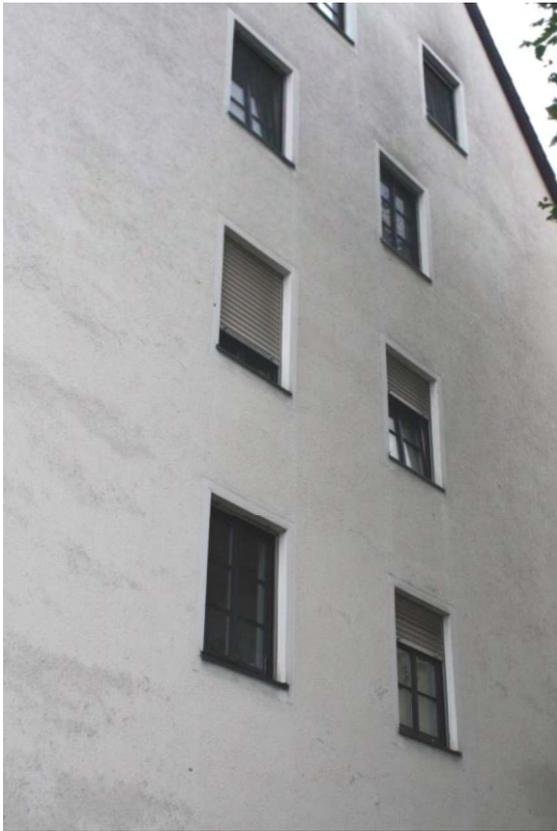
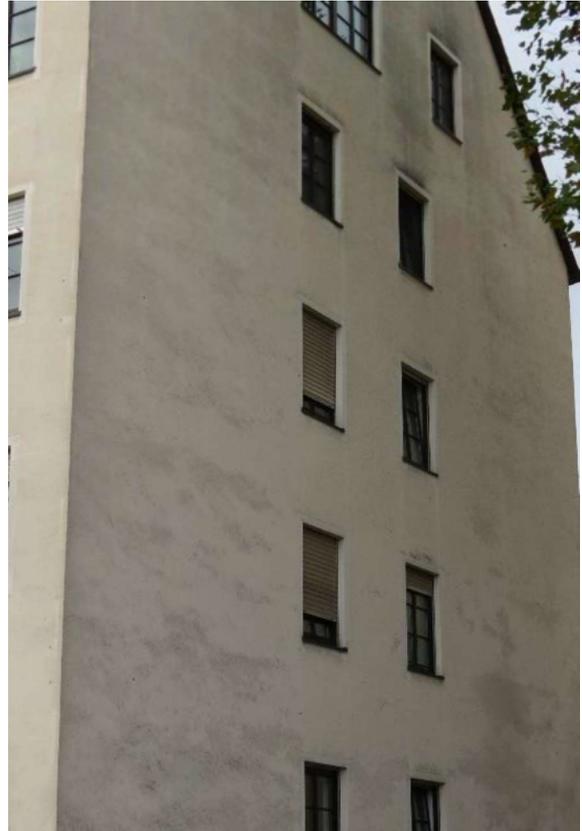
Object 96 was another building on which no renovation had been carried out since 2014. In Figure 7, the east side in 2014 is shown on the left and that in 2022 on the right. Since the last coat of paint was applied in 1995, some algae growth had occurred, which had only slightly increased in the past eight years. The façade is strongly shaded by a large tree and by the neighboring house, which is located a relatively short distance away. In addition, the light discolorations on the corners of the building (Figure 8) are still clearly visible in 2014 (left) and 2022 (right). The panel joints of the corner connection appear slightly here, but there has not been any noticeable change in the condition since the last assessment here either. Otherwise, there are no externally visible defects on the building facades.

Figure 7:
East side of object 96 (left in 2014 and right in 2022) with algae formation and slight rippling at the insulation panel joints. (The rippling is not caused by cavities in the plaster but by unevenness in the plaster layer that is recognizable by the different graying.).

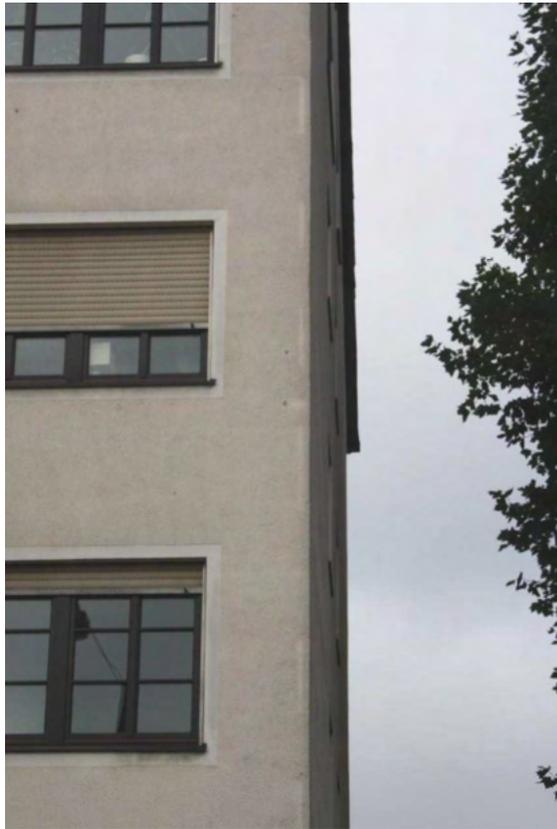
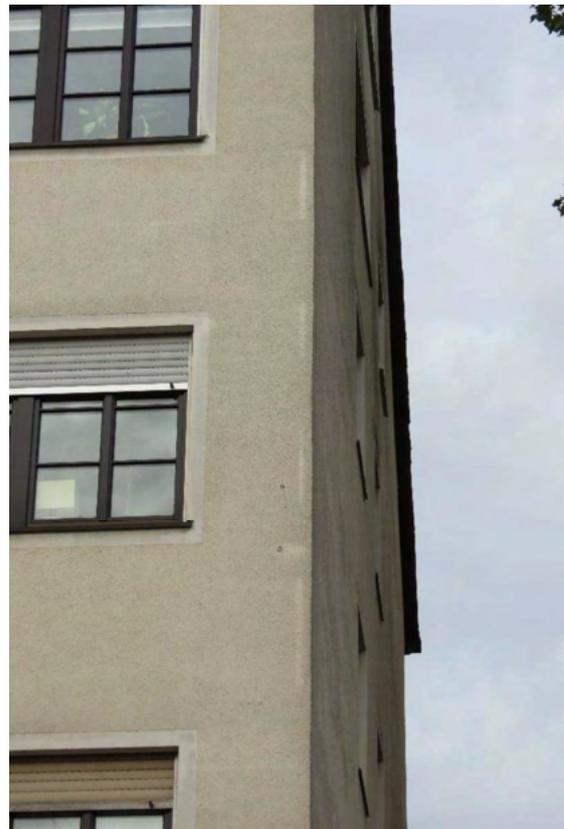
Figure 8:
South-east corner of object 96 with appearance of the insulation panel joints through color differences (hardly visible from a distance).
Left: View in 2014.
Right: View in 2022.

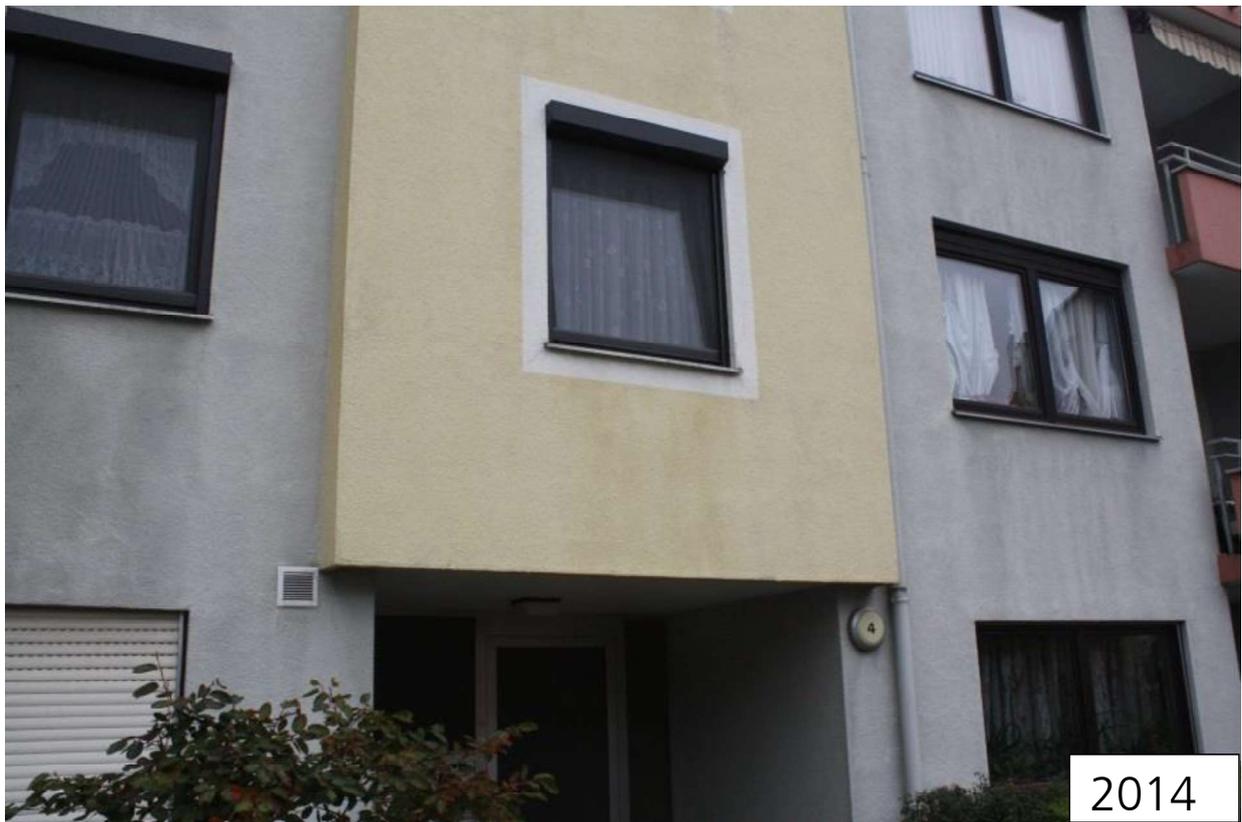
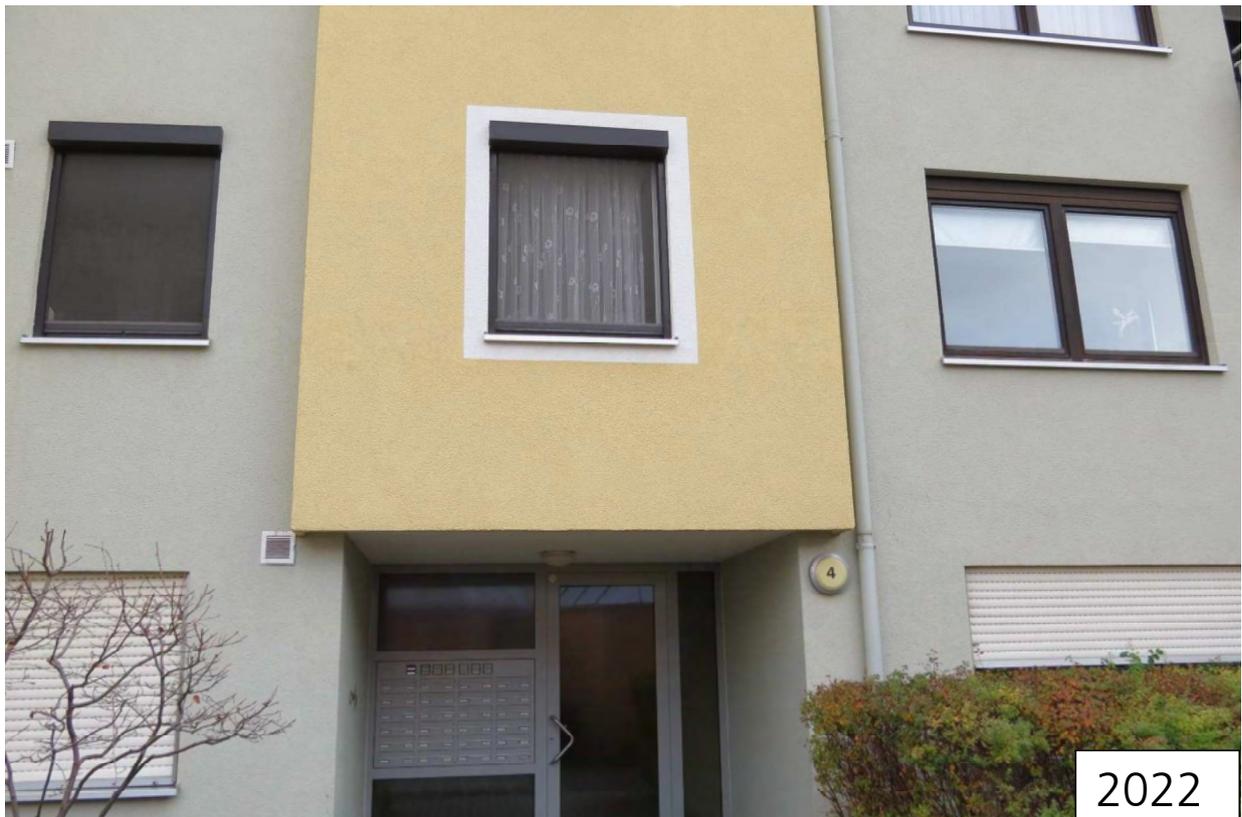
Figure 10:
View of the exterior façade with west orientation in 2014 (top) and 2022 (bottom).

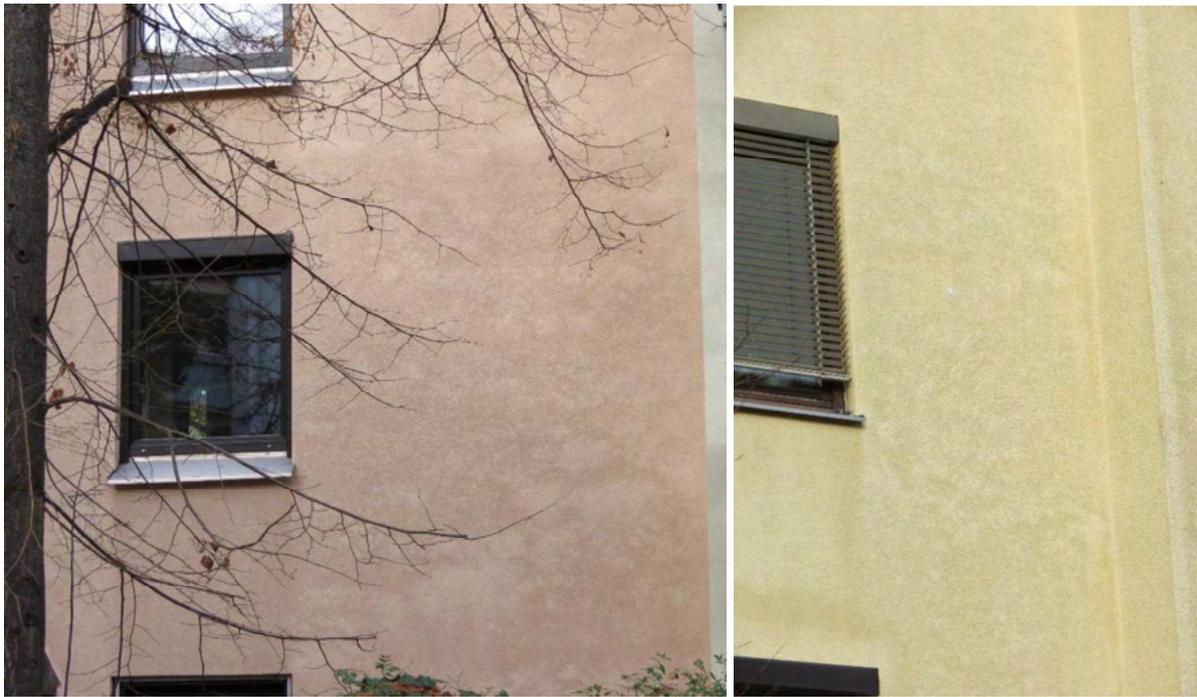
Figure 11:
View of the east façade (left) and south-east façade (right) on object 95 with noticeable splotch formation but no crack formation.

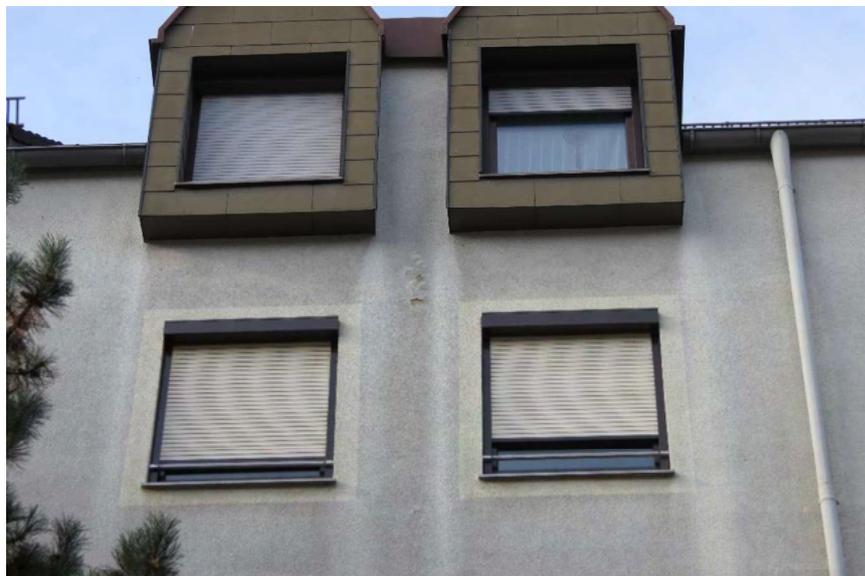
Figure 12:
View of the east façade of the part of the residential complex that borders Mathildenstrasse. Noticeable crack formation and plaster separation between the windows.

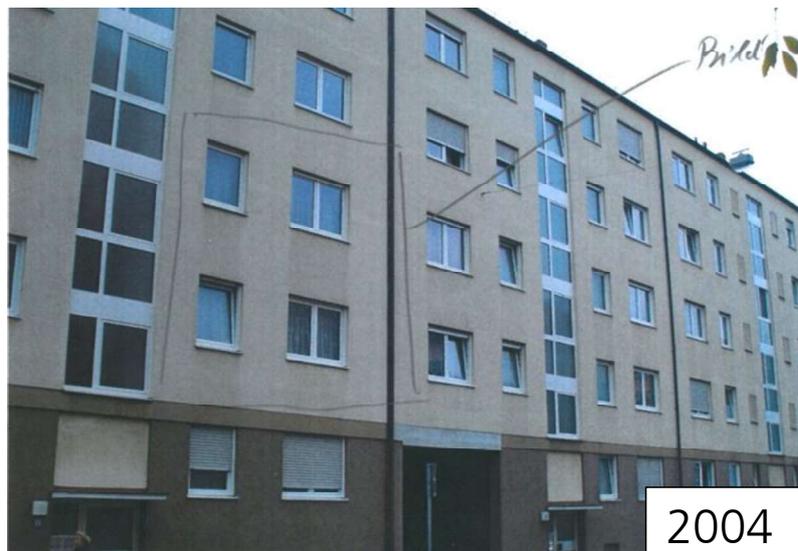
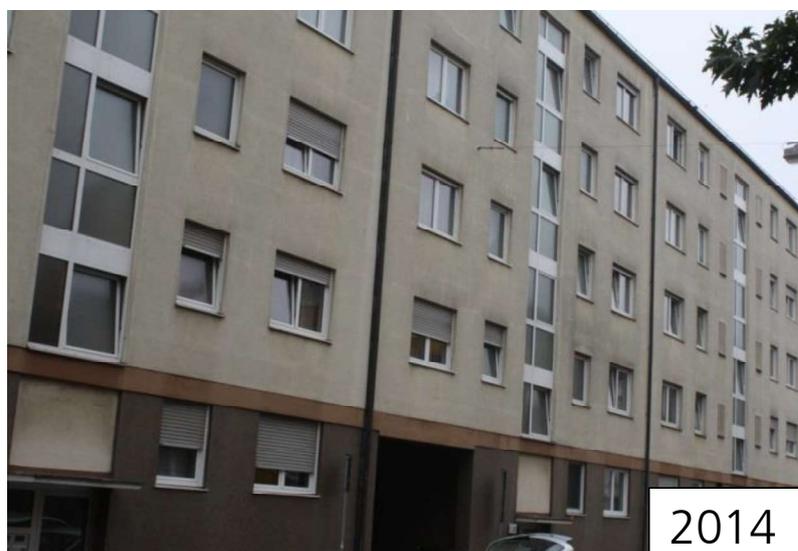
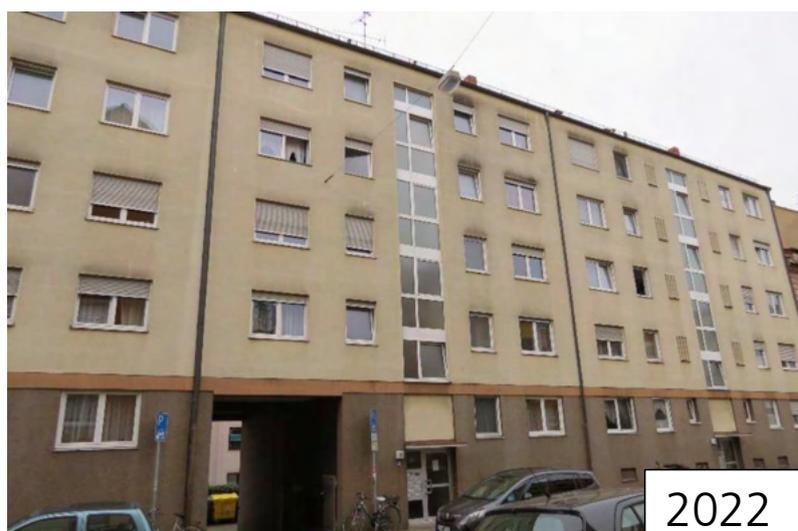
The changes in the north façade of object 51 can be seen in Figure 13 for the periods of 2004, 2014 and 2022. It was painted the last time 19 years ago. By now, the façade shows noticeable weathering characteristics as well as noticeable, extensive graying. Some lighter areas are still visible on the surface. It can be assumed that there is a joint of the insulation panel underneath. As a result of the different temperature conditions in these areas, a minimally changed microclimate occurs on the surface. Within the last eight years, the condition of the façade has optically grayed further, but no visible damage such as cracks or spalling is visible. Figure 14 additionally shows a section of the north façade in 2014 and 2022 on the upper stories. Clear condensation trails and light areas are visible on the plaster that appear along panel joints of the ETICS. No damage is visible. The south side of the building looks somewhat different, however. Isolated blistering was already visible here in 2014, and this has now developed further into noticeable cracks and bulges in the plaster. Figure 15 shows a close-up of the south façade in a balcony and at the connection to the garage in which blistering, and cracks are visible when comparing 2014 and 2022.

Figure 13:
North façade of object 51 in 2004 (top), 2014 (center) and 2022 (bottom).

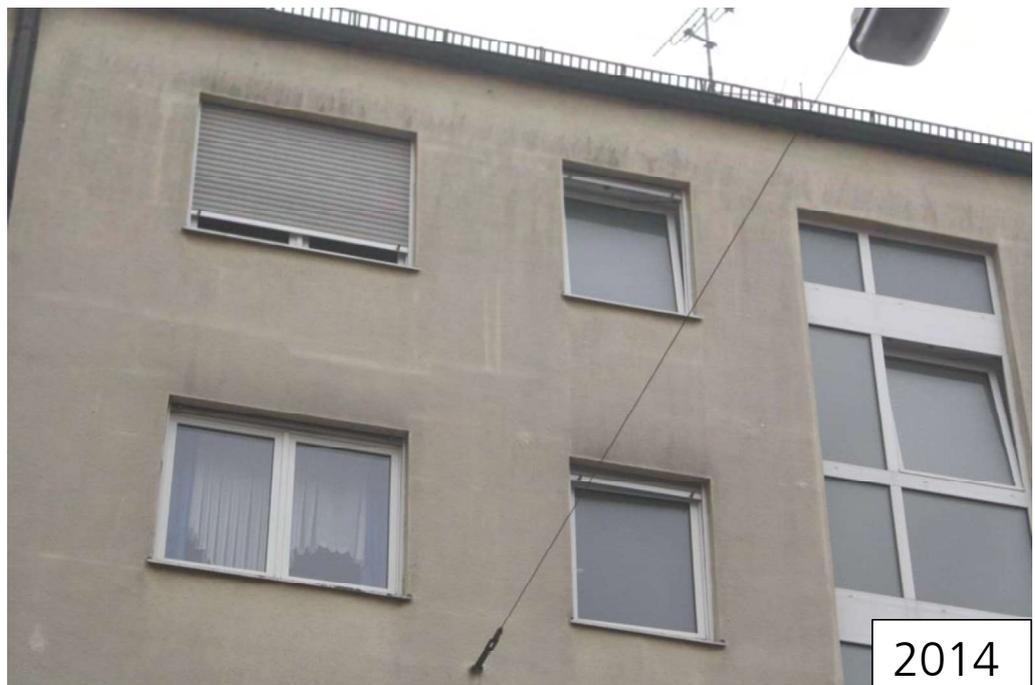
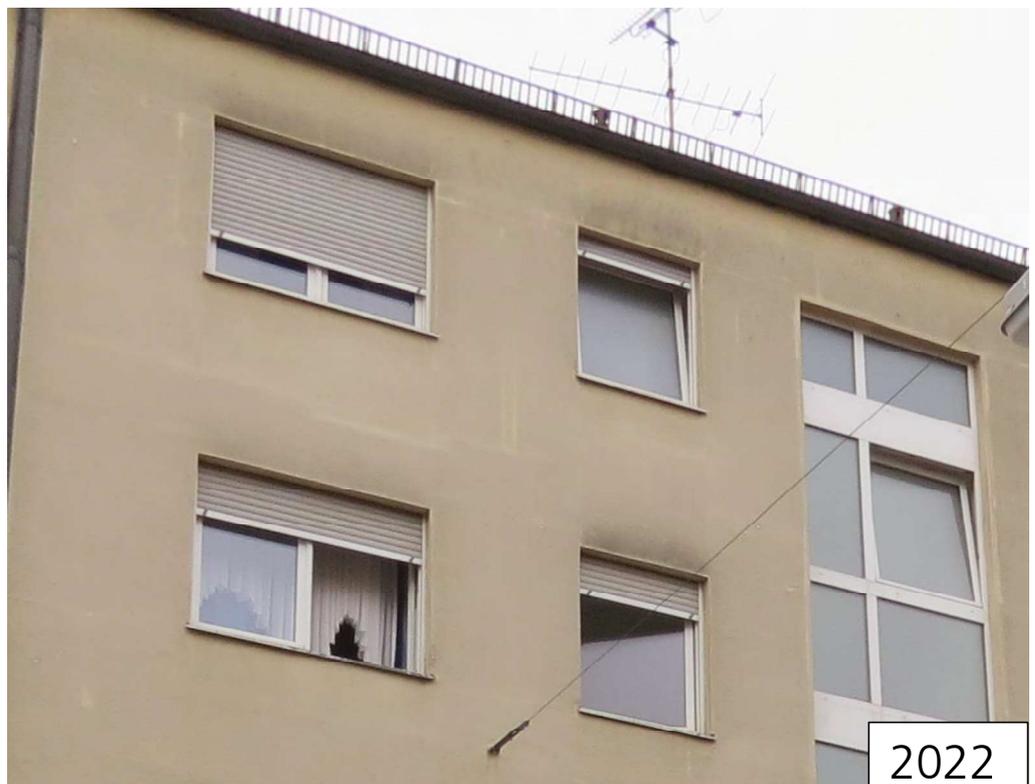
Figure 14:
View of the top north facade in 2014 (top) and 2022 (bottom) of object 51 on which noticeable condensation trails and light areas along the panel joints of the ETIC system are clearly visible.

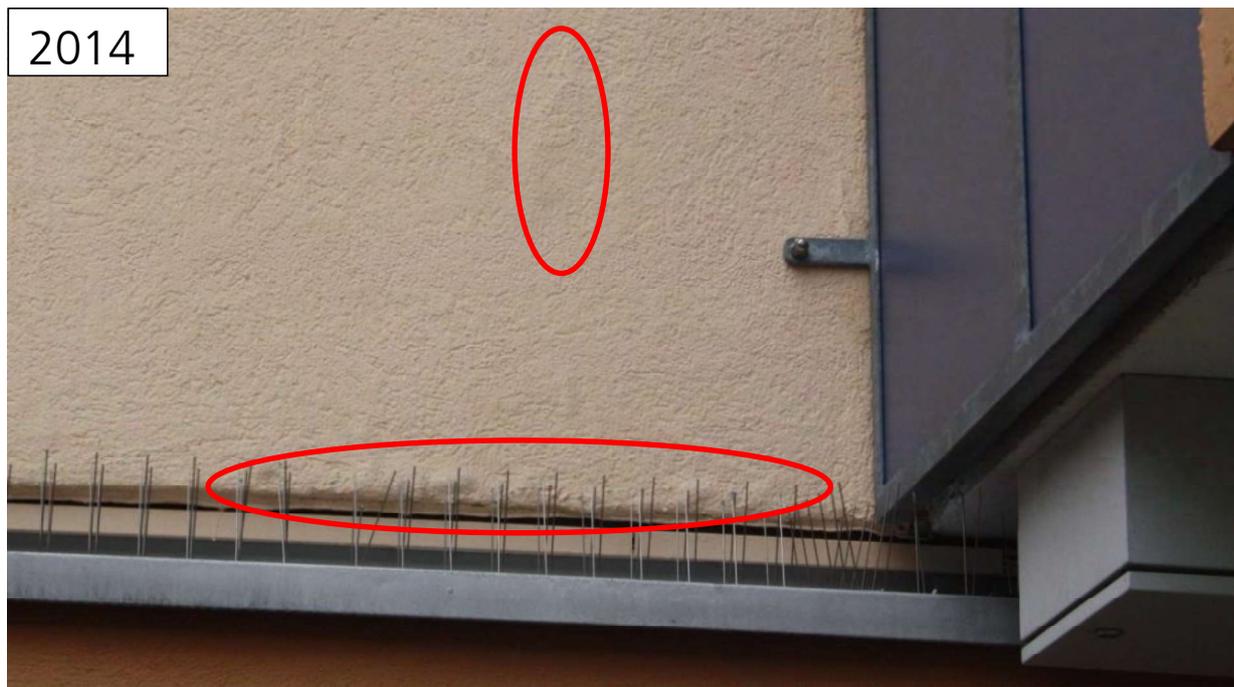
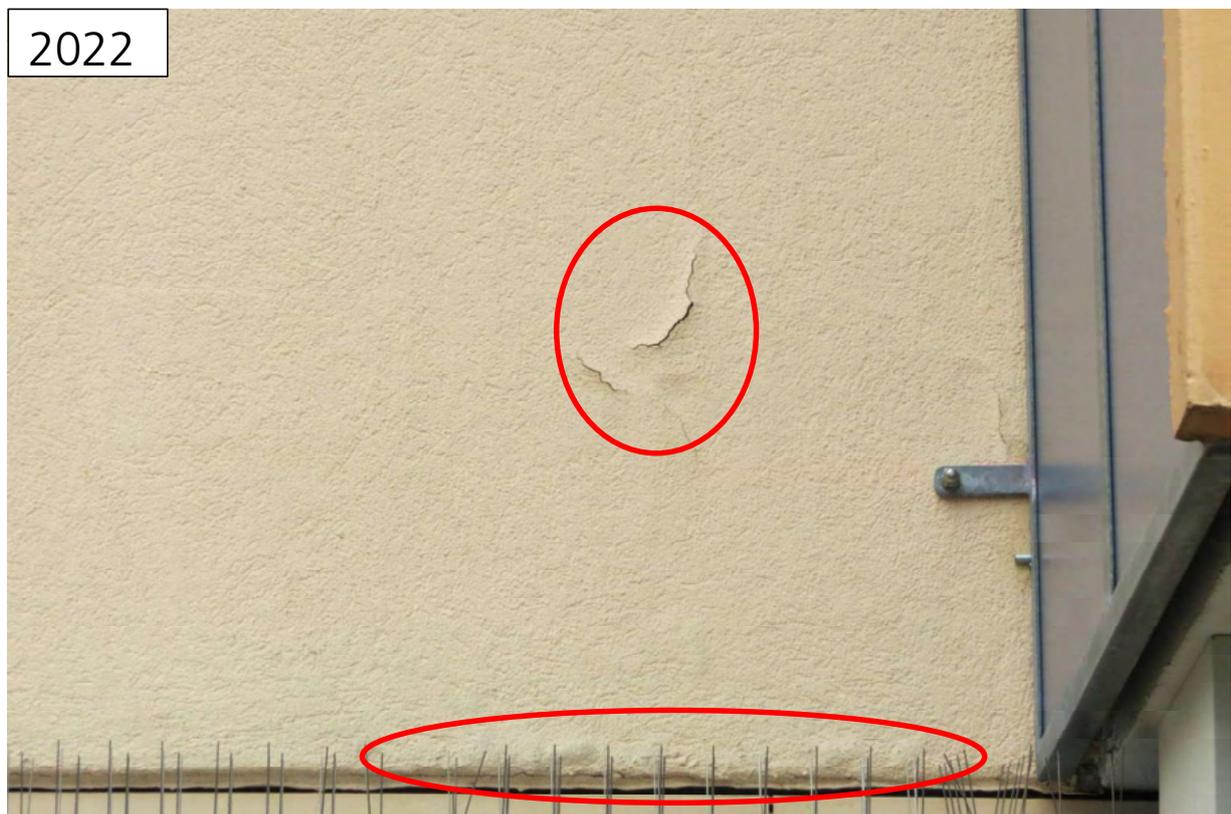
Figure 15:
View of the façade connection to the garages in 2014 (top) and 2022 (bottom) on the south side of object 51; noticeable blistering or crack formation is visible here on the lower plaster edge as well as occasionally in the plaster surface.

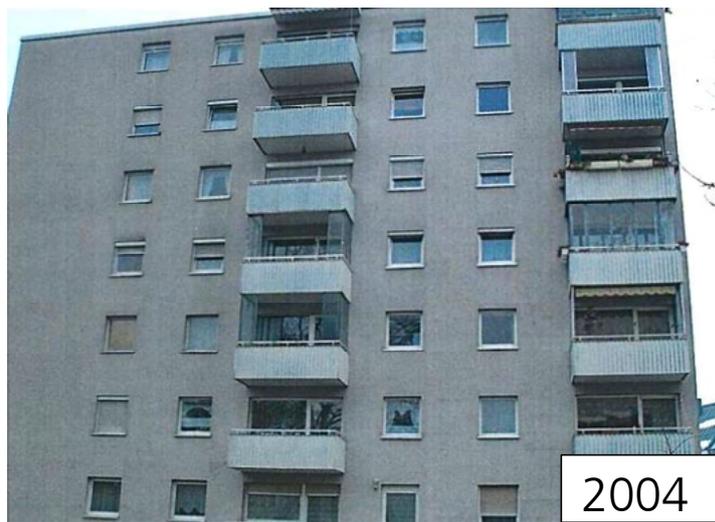
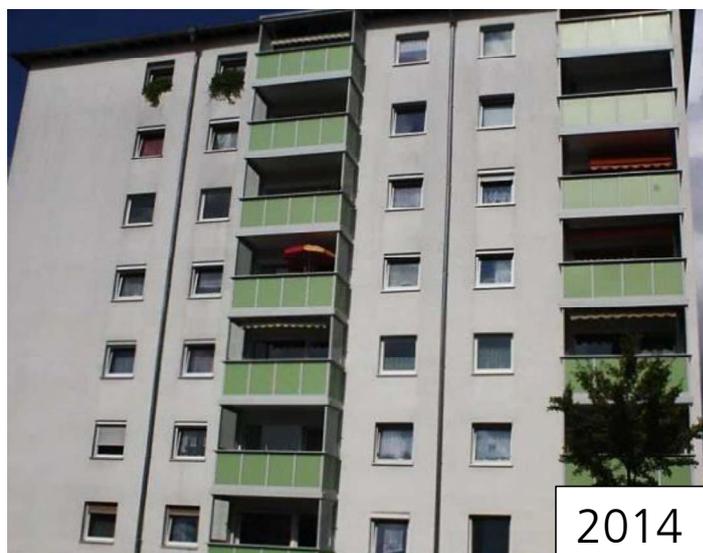
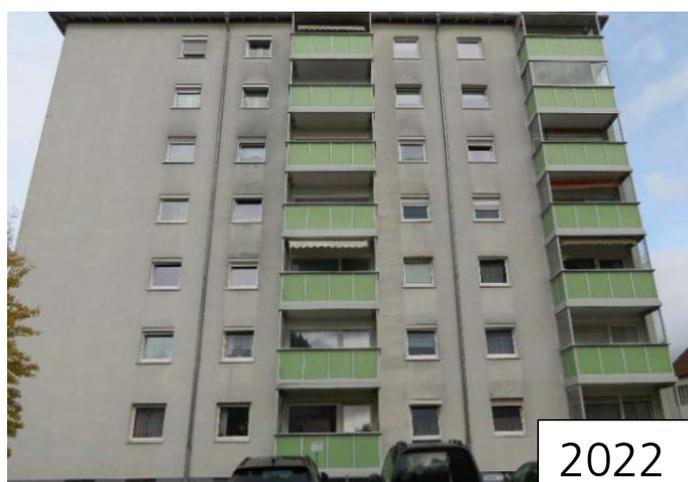
Object 56 in Neumarkt i. d. Oberpfalz was last painted in 2008. Figure 16 shows the view of the south façade in 2004 at the top, in 2014 in the center and in 2022 at the bottom. The façades have considerably grayed in the past eight years, but no crack formation or spalling is visible. On the east side, a slight rippling (see Figure 17 - top in 2014, bottom in 2022) in the plaster surface is visible where the edges of the ETICS panels appear with an oblique light incidence. This phenomenon is not considered a defect since it can occur due to slight differences in the thickness of the insulation panels and due to fluctuations in the layer thicknesses when a thin plaster is applied. Otherwise, a noticeable graying is visible over the entire surface here as well.

Figure 16:
South view of the façade of object 56 (formerly Efastr.), in 2004 (top), 2014 (center) and 2022 (bottom).

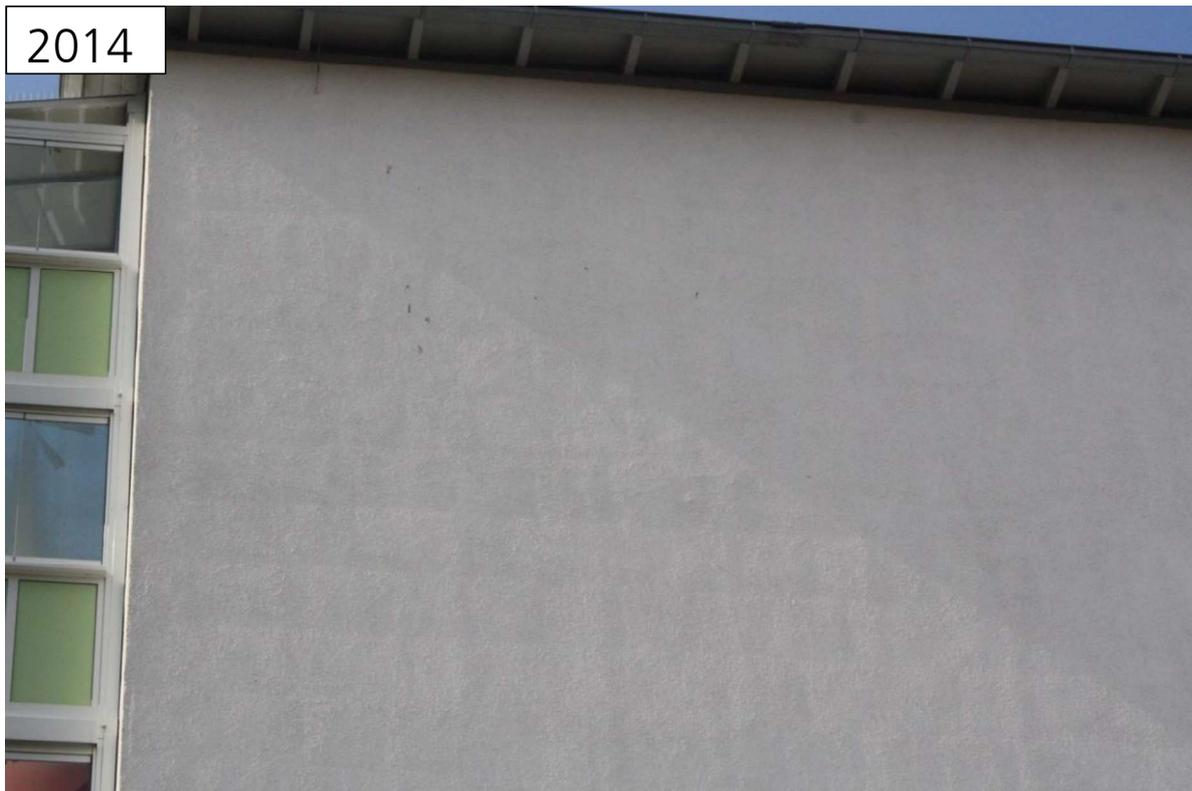
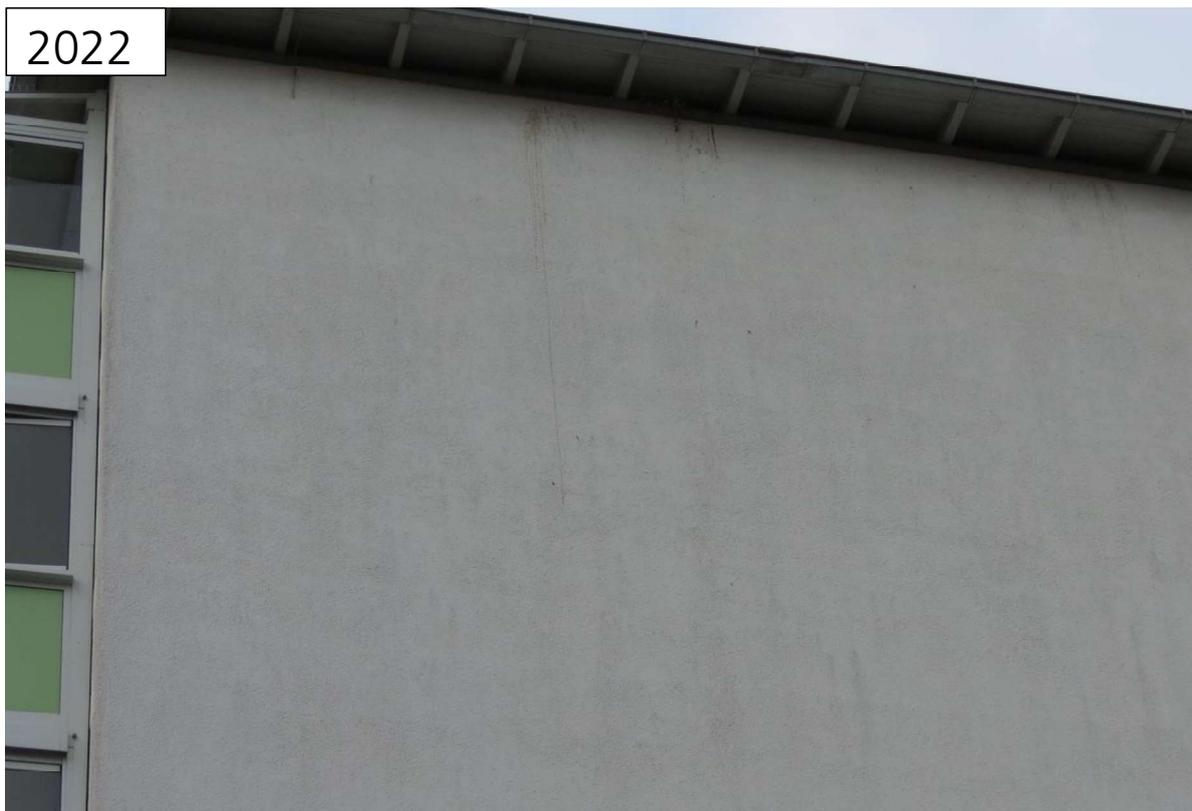
Figure 17:
East façade in 2014 (top) and 2022 (bottom) of object 56 with slight rippling at the panel joints of the insulation, which is only visible with oblique light incidence.

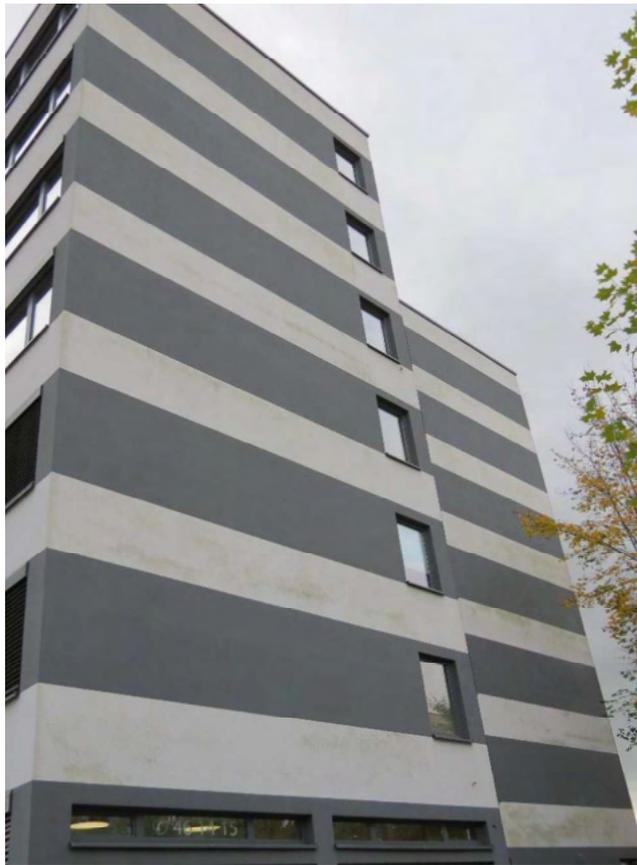
Figure 19:
North façade of object 54 in Neumarkt in 2022 with noticeable greening in the white façade areas.

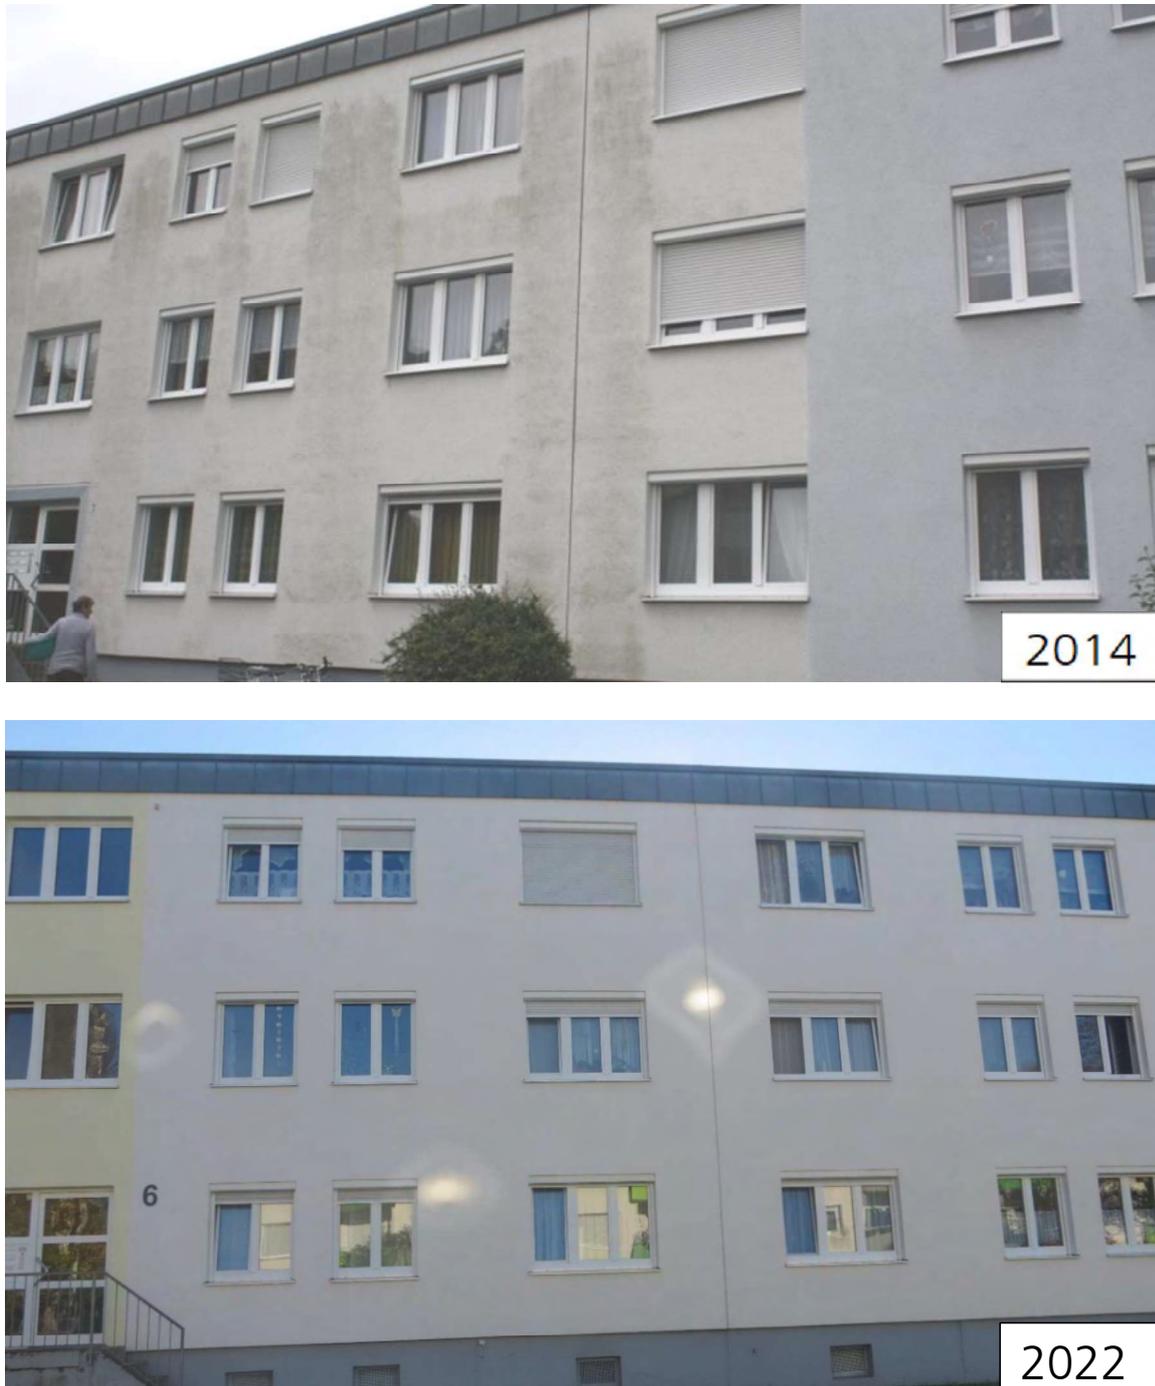
On object 34, the façade coating had been renovated with a silicone resin paint in 2020 and was without visible defects. The comparison of the façade view from 2014 to 2022 is shown in Figure 21.

Figure 21:
North façade of object 34, in 2014 (top) with noticeable discolorations of the white plaster surfaces and in 2022 (bottom), freshly painted approx. two years before.

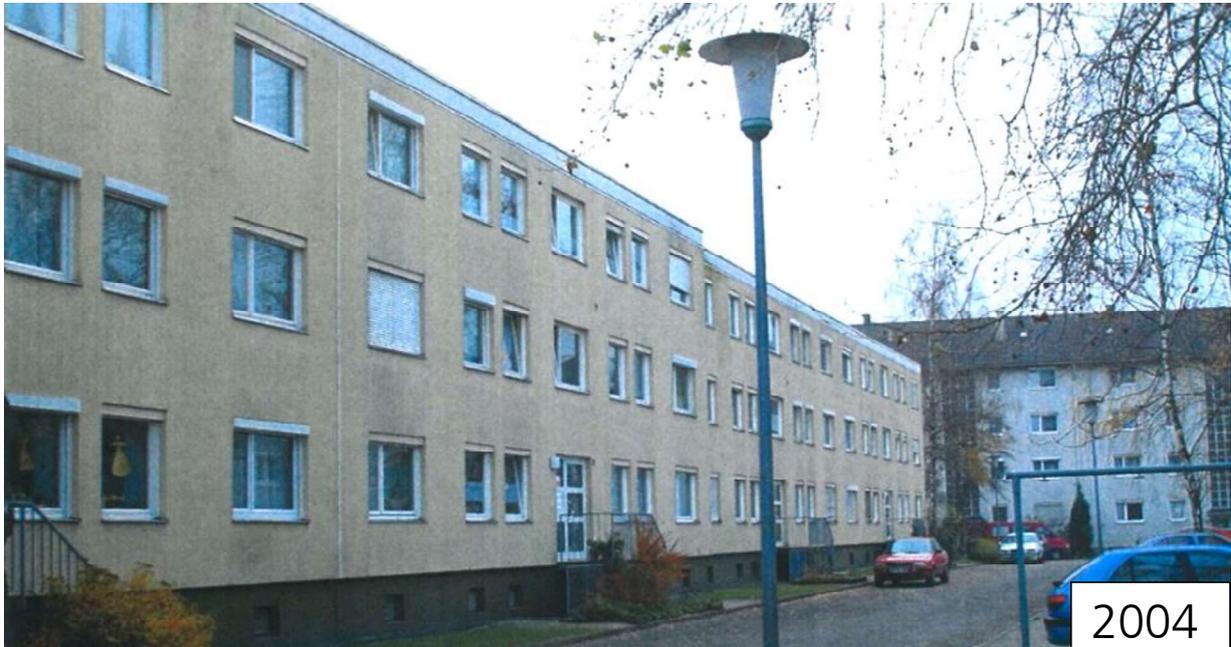
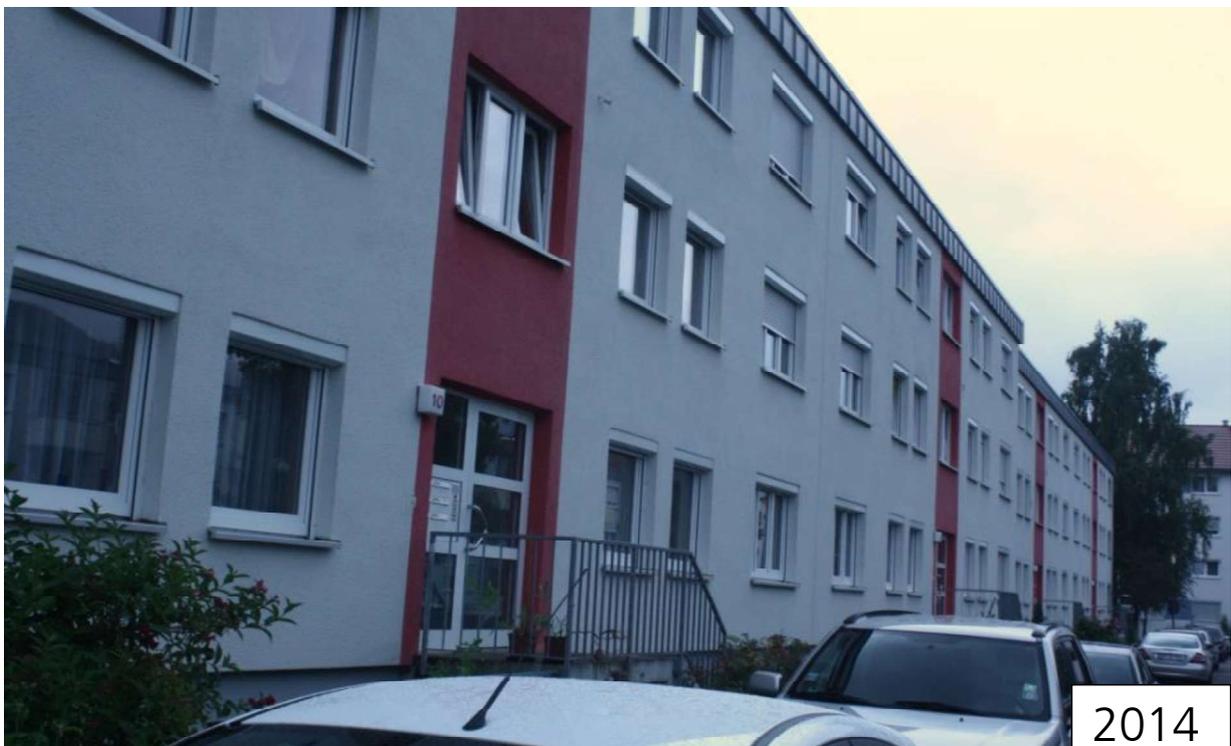
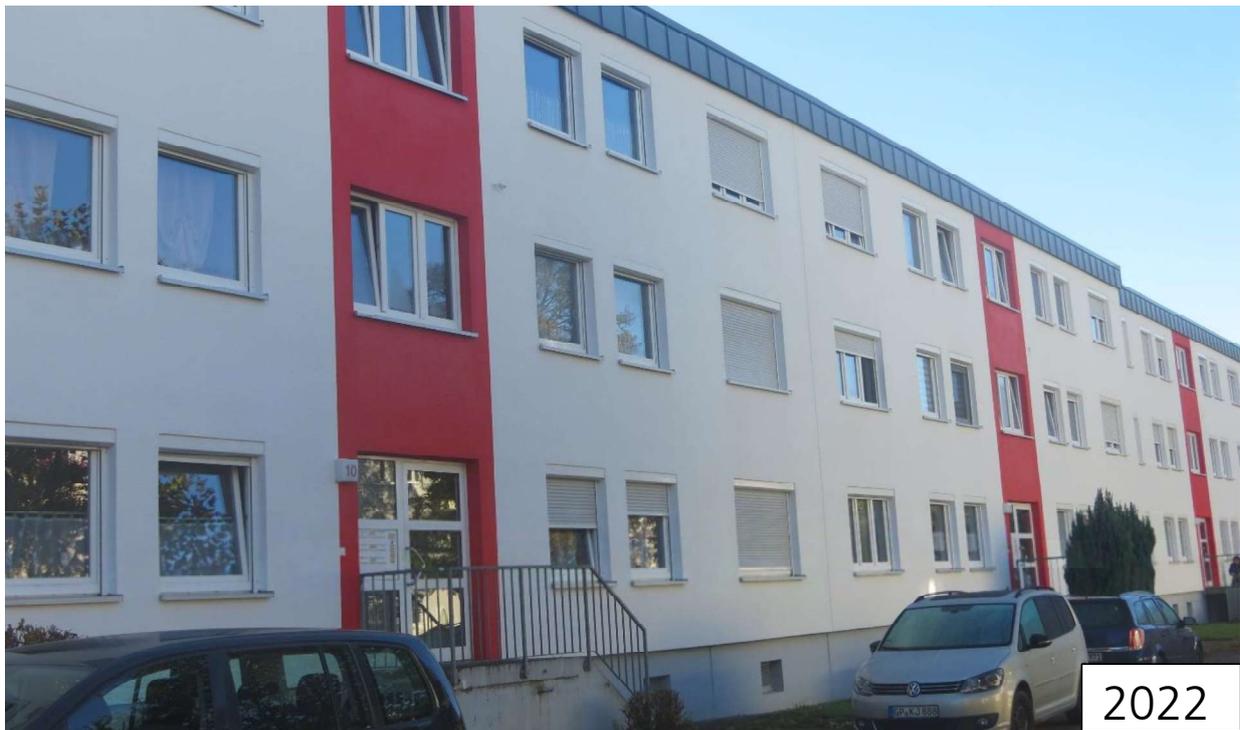
Object 33 is characterized by the same structure and the same location as the previous property 34, with the difference that this building façade was renovated in 2022 with a new coat of paint. Figure 22 shows images of the north façade in 2004, 2014 and 2022. No defects are visible.

Figure 22:
North view of object 33 (Bolzstr. 9–12, Geislingen a. d. Steige), in 2004 (top), 2014 (center) and 2022 (below).
