Fraunhofer Institute for Building Physics IBP

IBP report HTB-005EN/2023

Assessment of the long-term reliability of installed external thermal insulation composite systems

Conducted on behalf of
Verband für Dämmsysteme, Putz und Mörtel e.V.
Reinhardtstraße 14
10117 Berlin, Germany

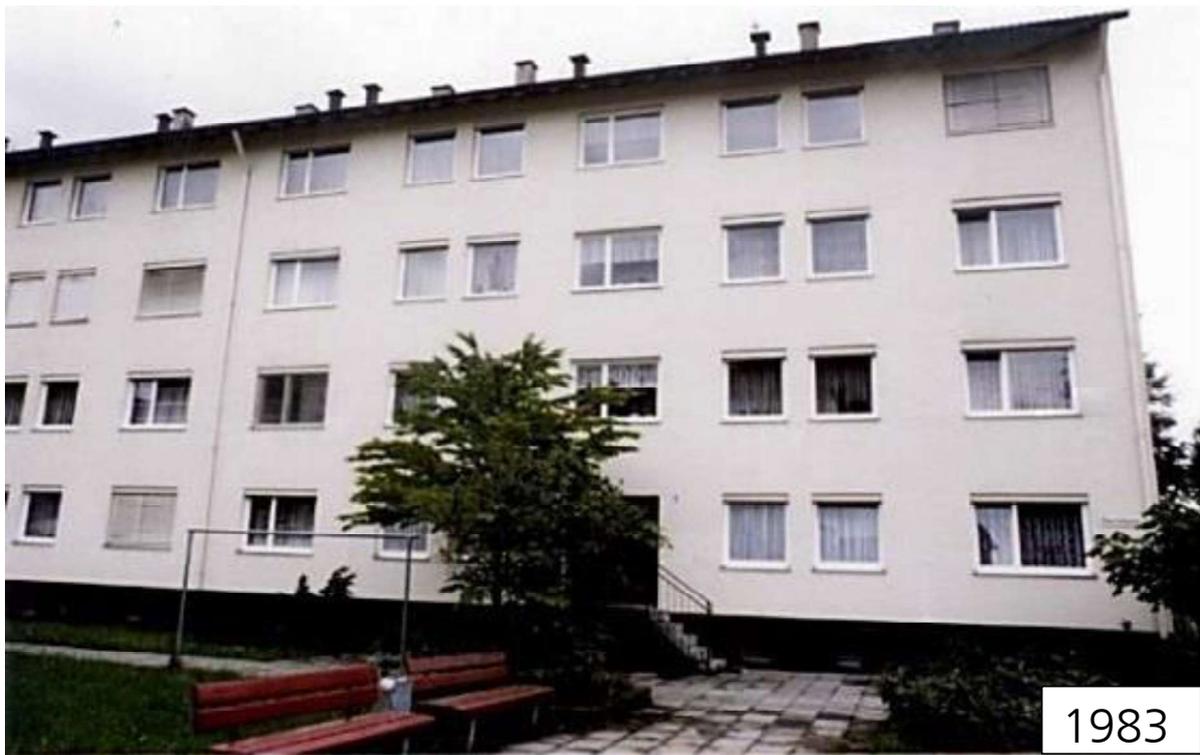
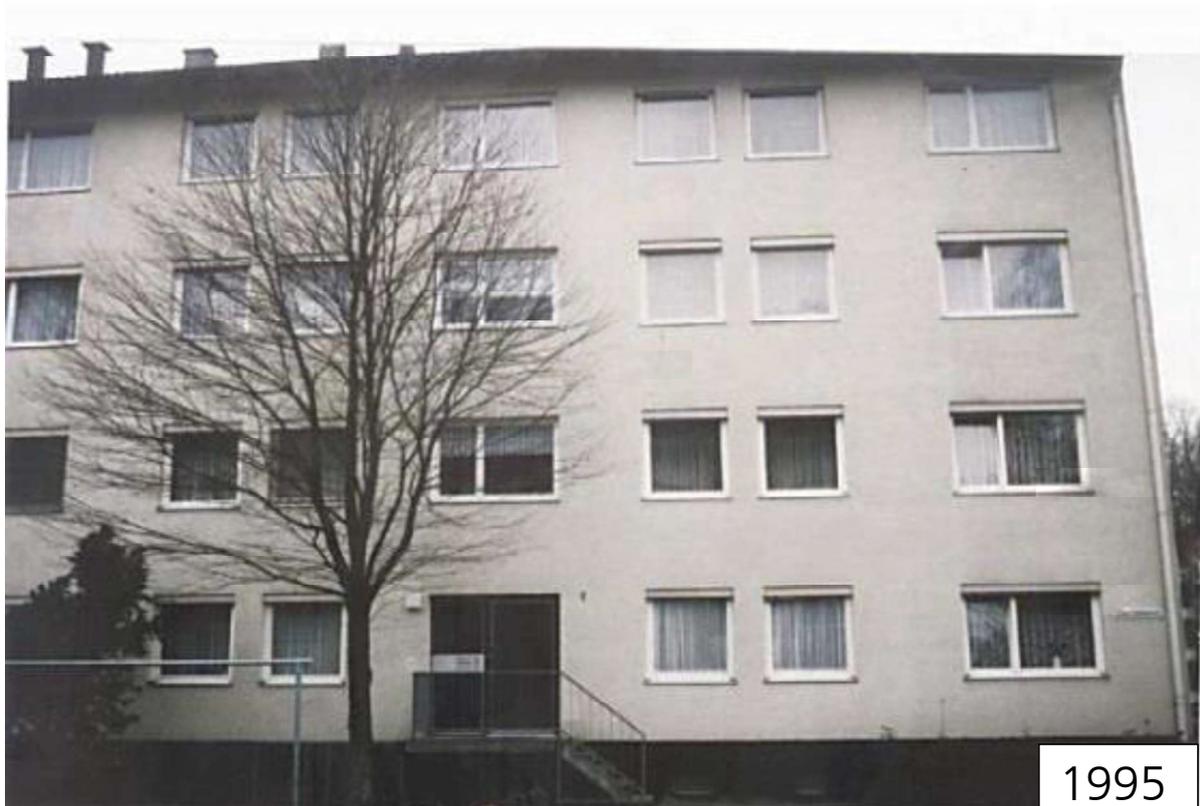
For object 32, Figure 23 to Figure 25 show the chronological sequence of the views of the north façade over the course of the last 39 years. In the period of 1981–2006, no work took place on the façade. Since the energy-related renovation measures in 2006, the façade of the building had not been worked on. The pictures from 1983 to 2022 do not show any crack formation or spalling defects over the years. The picture from 2022, however, shows noticeable discolorations and appearance of the ETICS dowels in the upper stories on the façade. Figure 26 shows the east view of the building in comparison: in 2014 on the left and in 2022 on the right. The graying has become more noticeable, and the ETICS dowels clearly appear on the entire façade surface. In the connection area to the grass strip, it is evident that algae growth / soiling has considerably increased since 2014 (see Figure 27). This is due to the short distance to the grassy area and the related spray water.

Figure 23:
View of the north façade of property 32 (Ebertstr. 1–7, Geislingen a. d. Steige)
in the period between 1983 and 1995.

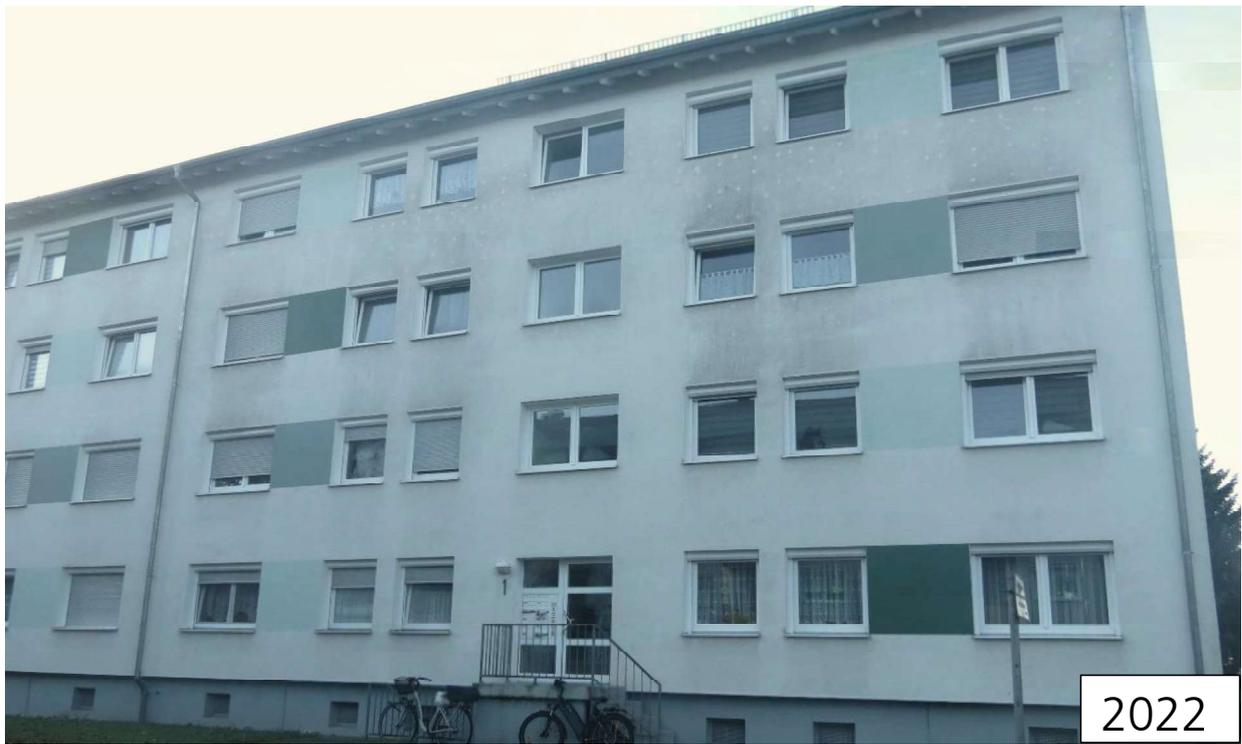
Figure 25:
View of the north façade of object 32 (Ebertstr. 1–7, Geislingen a. d. Steige) in
October 2022.

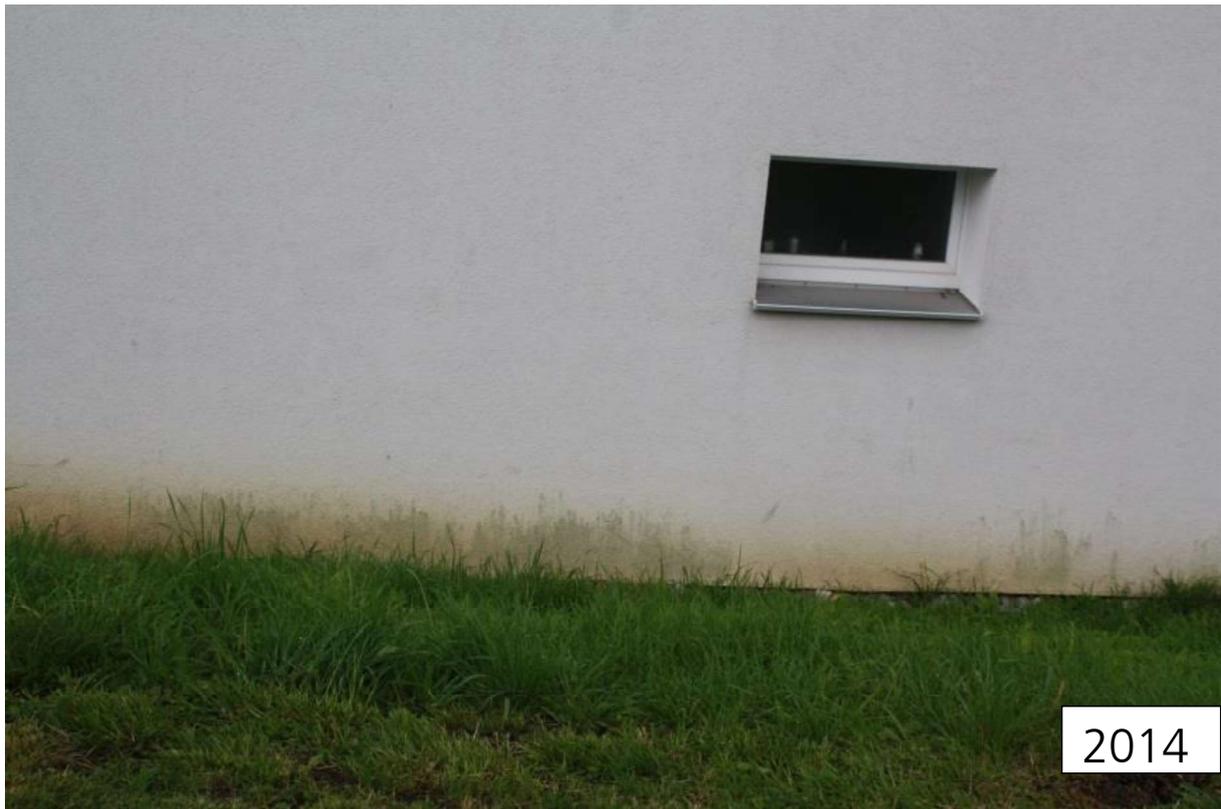
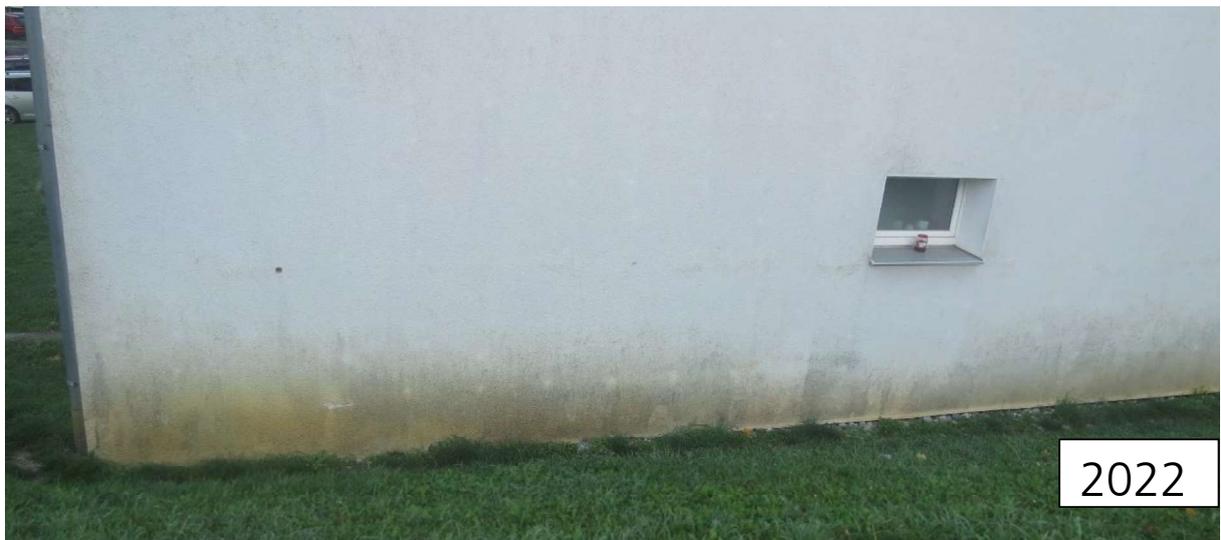
Figure 27:
View of the lower east façade surface in 2014 (top) and 2022 (bottom) at the connection to the grass strips with noticeable algae growth and soiling of the plaster surface by spray water as well as the appearance of dowel areas.

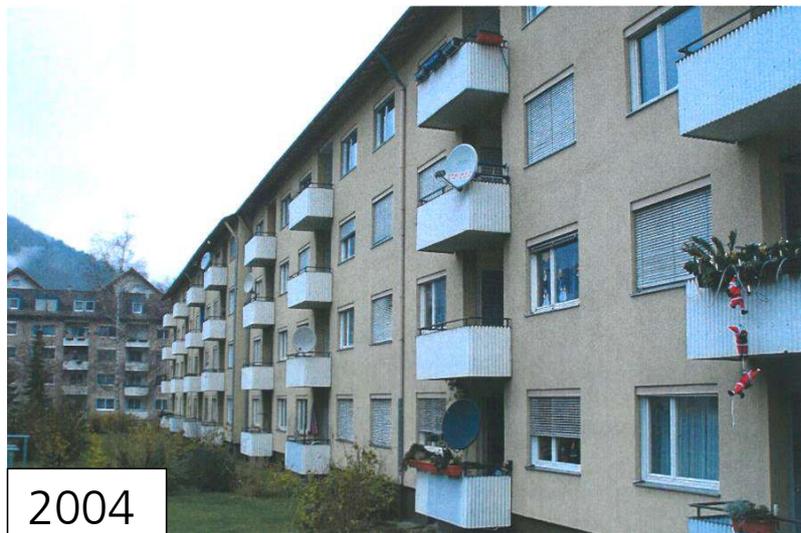
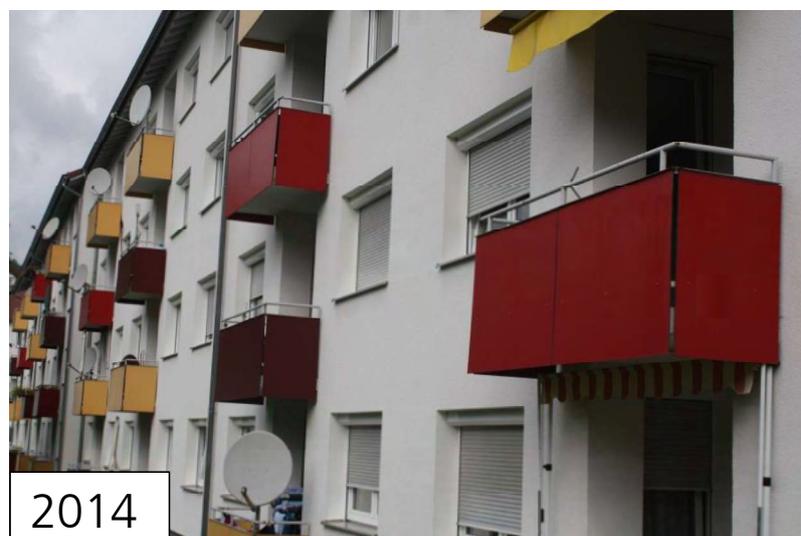
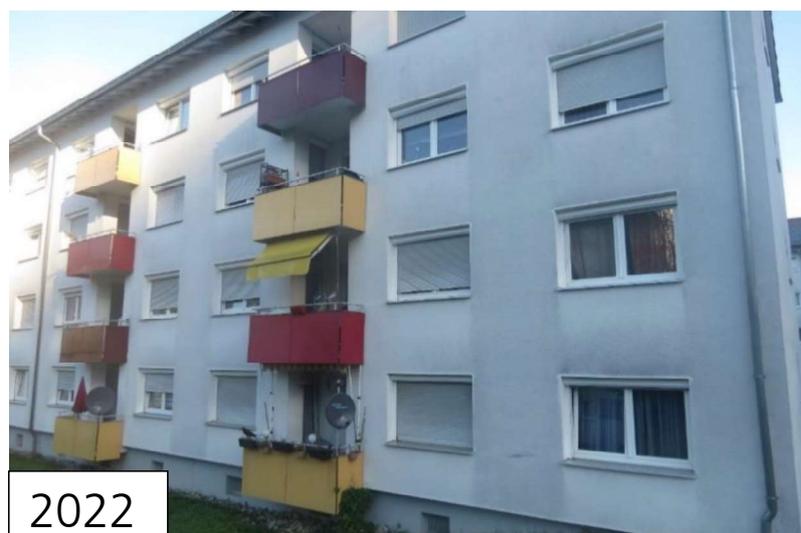
On object 31, no façade renovation measures had been carried out since 2006. Figure 28 shows the south view of the building in 2004, 2014 and 2022. There are no crack formation or blistering defects on this building. Overall, a noticeable graying of the façade is visible mainly in the area between the windows. On the west façade (see Figure 29), extensive graying of the entire façade is visible, but no crack formation.

Figure 28:
View of the south façades of object 31 (Brüningstr. 2–6, Geislingen a. d. Steige), in 2004 (top), 2014 (center) and 2022 (bottom).

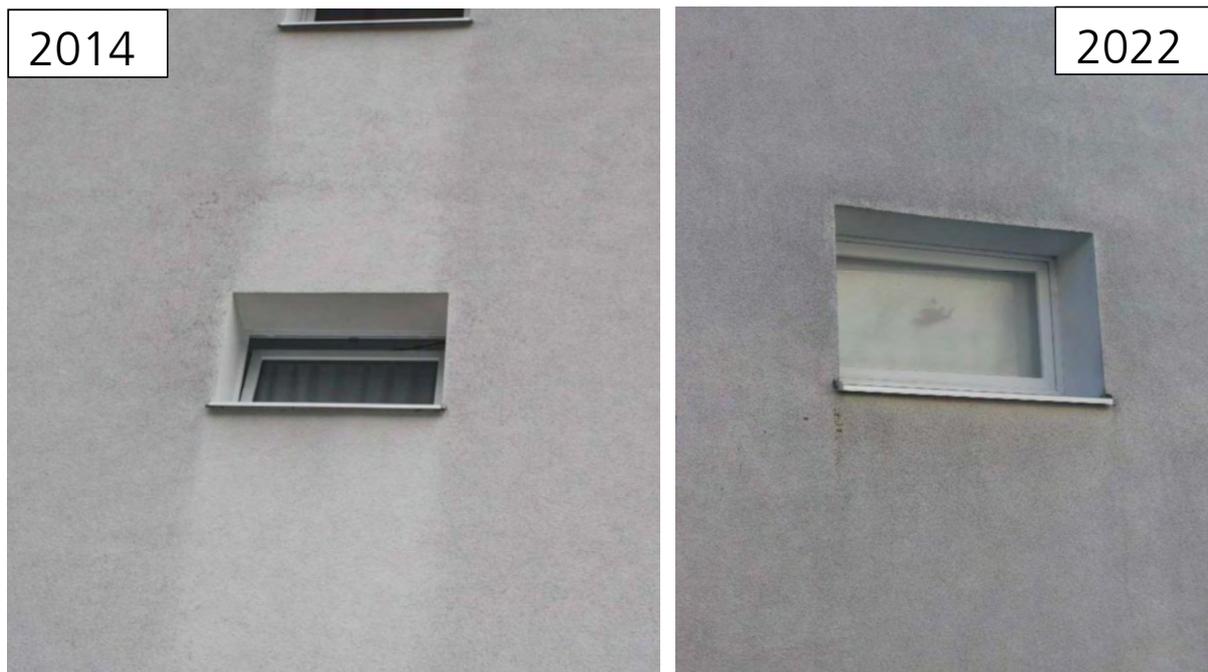
Figure 29:
View of the west façade of object 31; in 2014, noticeable color differences could be seen between the area underneath the windows and the undisturbed façade; in 2022 an even graying is visible.

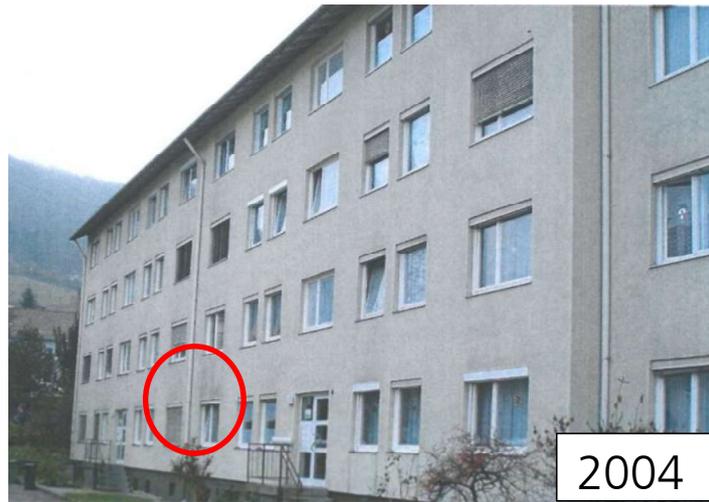
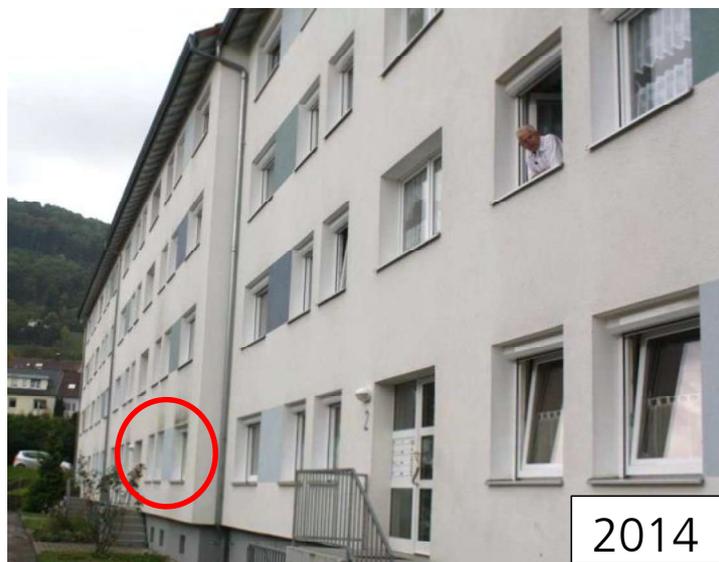
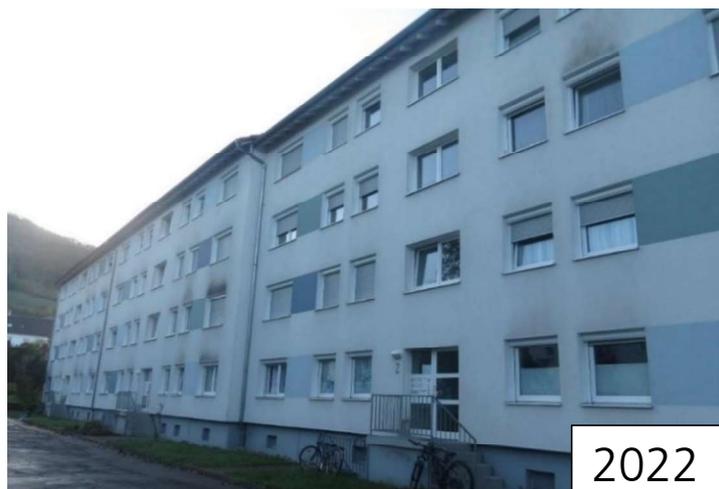
On object 30, no façade renovation measures had been carried out since 2006 either. Figure 30 shows the view of the north façade in 2004, 2014 and 2022. On the façade, the growth of black fungus is seen above the windows on several residential units on the first floor, just like in 2004 and 2014; this is due to windows that had been tilted open for a longer time. Here, moist, warm indoor air flows upwards along the façade and condensate forms because of the cold surface, leading to the formation and growth of black fungus. Except for the usual graying, no defects could be detected on the façade. Another, more noticeable detail can be seen in Figure 31. In 2014, algae growth occurred on the south-west corner of the building, which only appeared on the edge of the building. During the assessment in 2022, there was algae growth on the north-west corner of the building as well as the beginning of algae growth over the surface of the façade. In addition, significant condensation trails were visible in the upper area of the west façade (see Figure 32).

Figure 30:
View of the north façade of object 30 (Stresemannstr. 2–6, Geislingen a. d. Steige), in 2004 (top), 2014 (center) and 2022 (bottom).

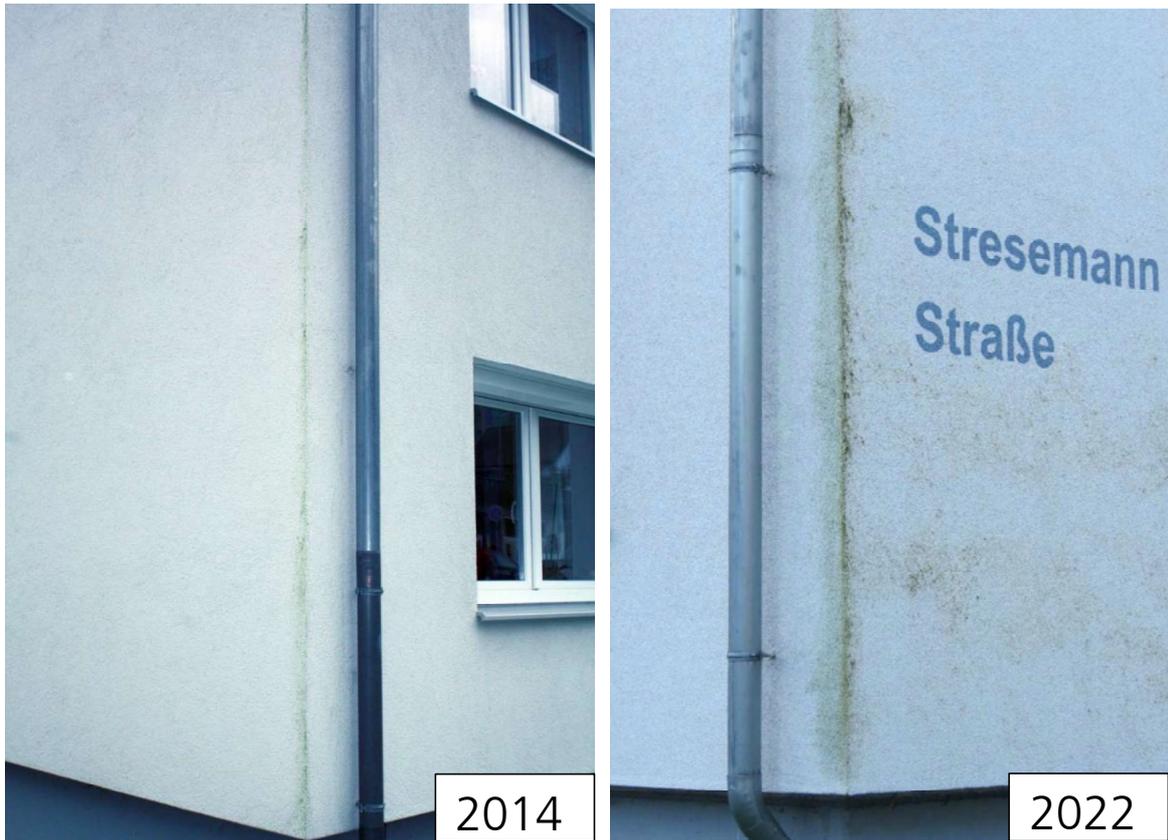
Figure 31:
View of the south-west corner of the building in 2014 (left) of object 30 and the north-west corner of the building in 2022 (right) with algae growth on the edge of the building.

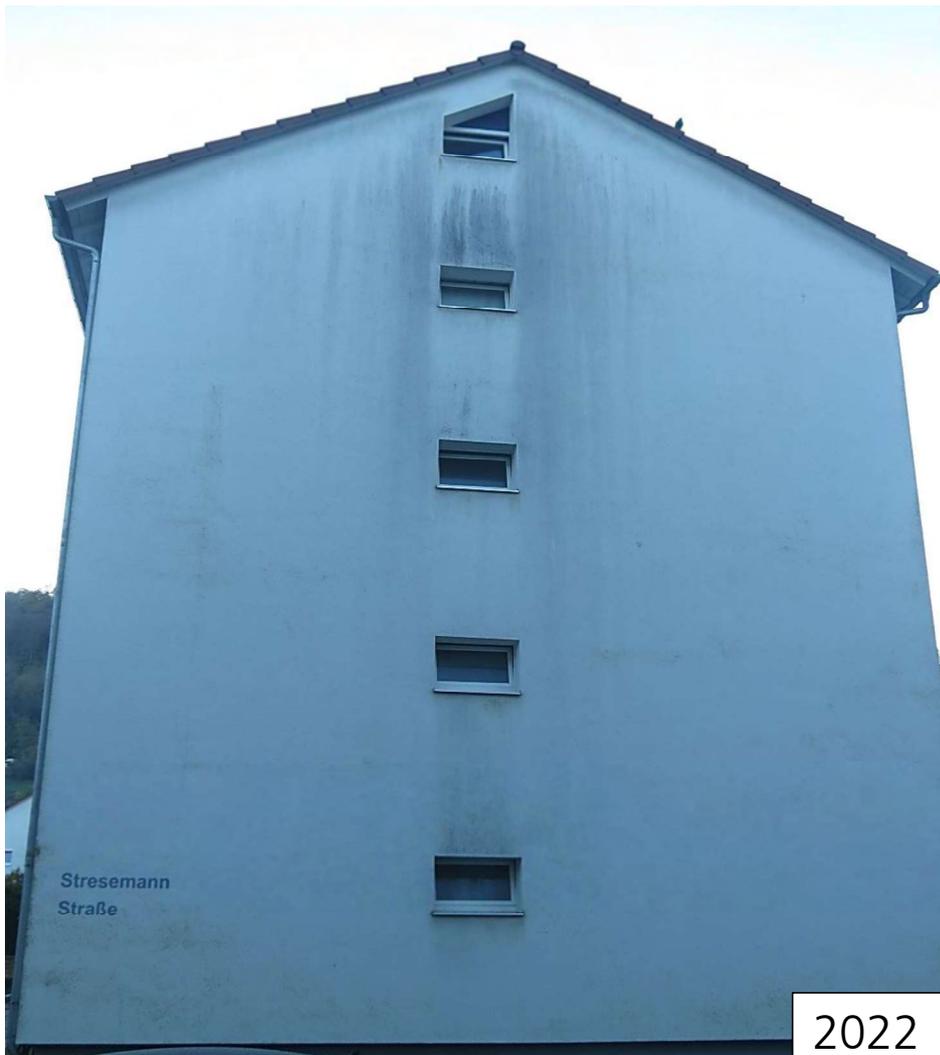
Figure 32:
View of the west façade (2022) of object 30 with noticeable condensation trails and the beginnings of algae growth.

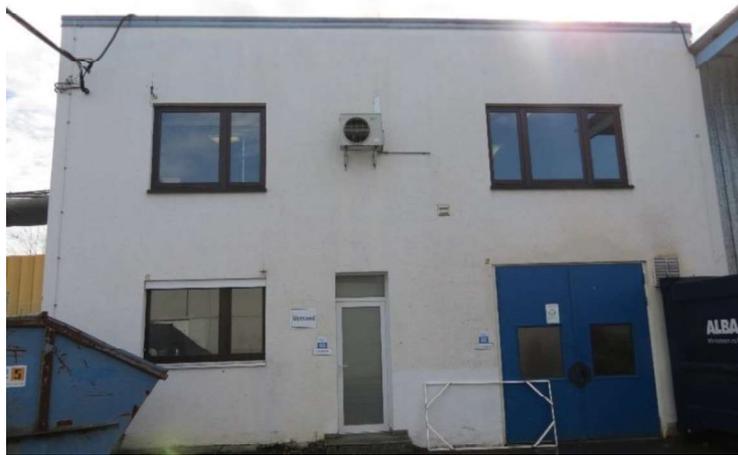
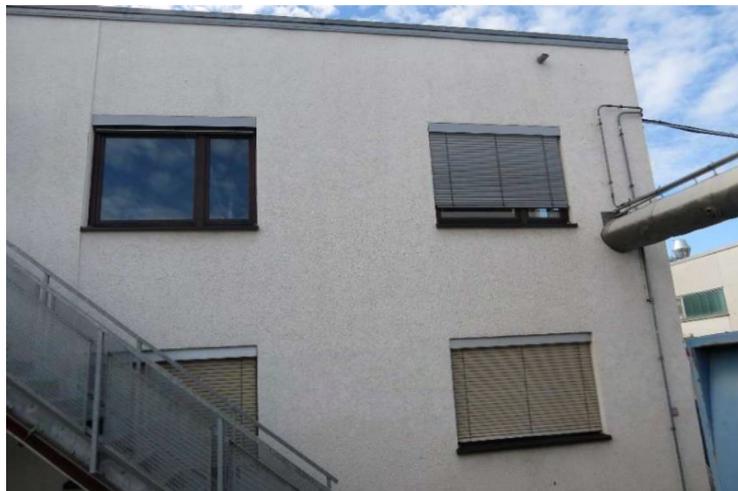
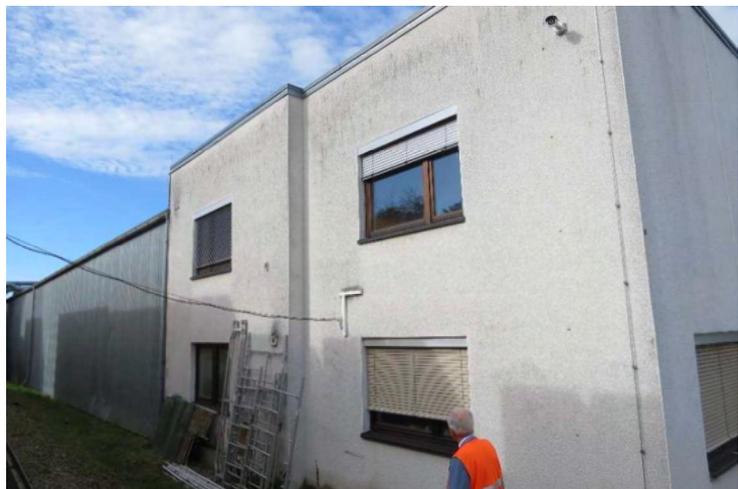
Object 2 is a workshop building that was built in 1973 and insulated in 1986 with 5 cm PUR/PIR insulation and mineral plaster. Since then, the façades have not been renovated anymore. The façade construction was thus 36 years old. No damage is visible over any of the surfaces (see Figure 33). Some damage can be seen only in the base area, although this is likely to have been caused by mechanical influences. Biological growth is also discernible in the lower area of the façade, which is probably due to spray water from the ground. On the south side (Figure 34), noticeable gray areas and condensation trails are visible in the upper façade area.

Figure 33:
View of the three façades of object 2.
Top: north façade.
Center: east façade.
Bottom: south façade.

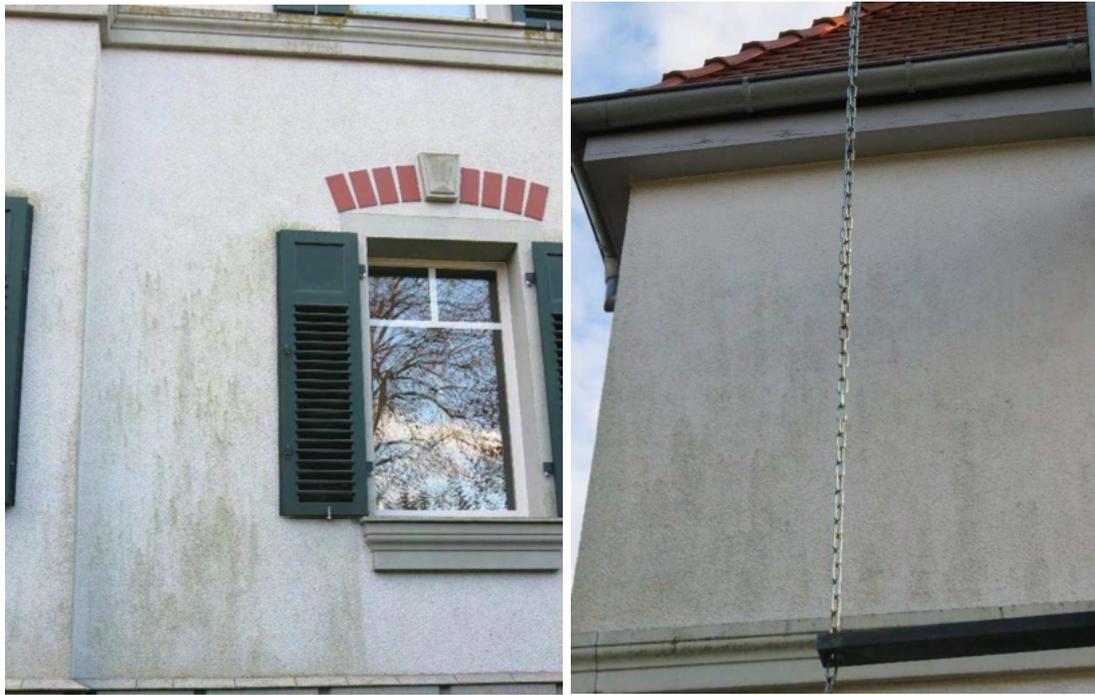
Figure 43:
Close-up of the NW façade (left) and SW façade (right) with noticeable green-
ing.

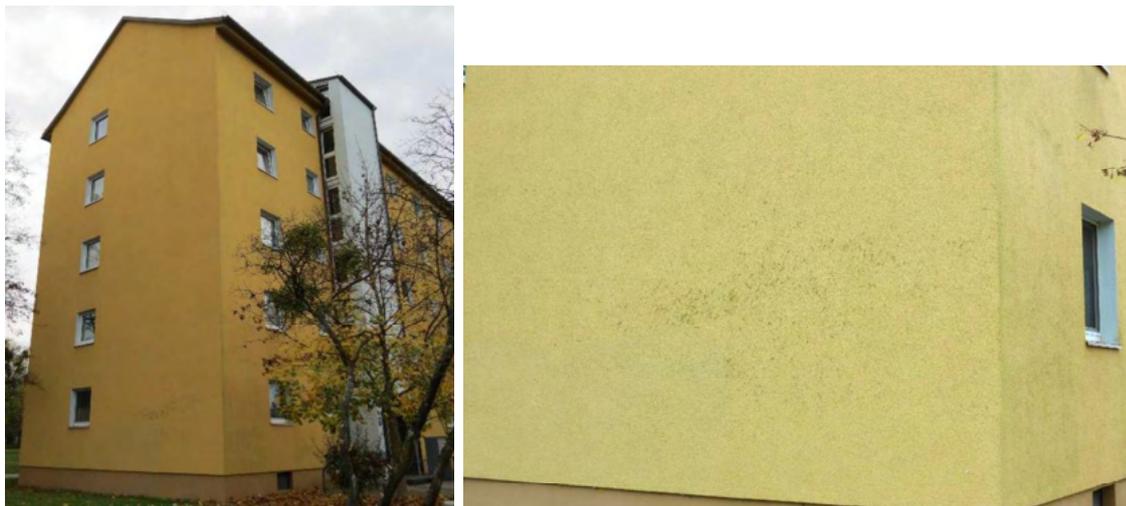
Figure 48:
View of the east façade of house number 85, including a close-up of the lower north-east façade surface with algae growth.

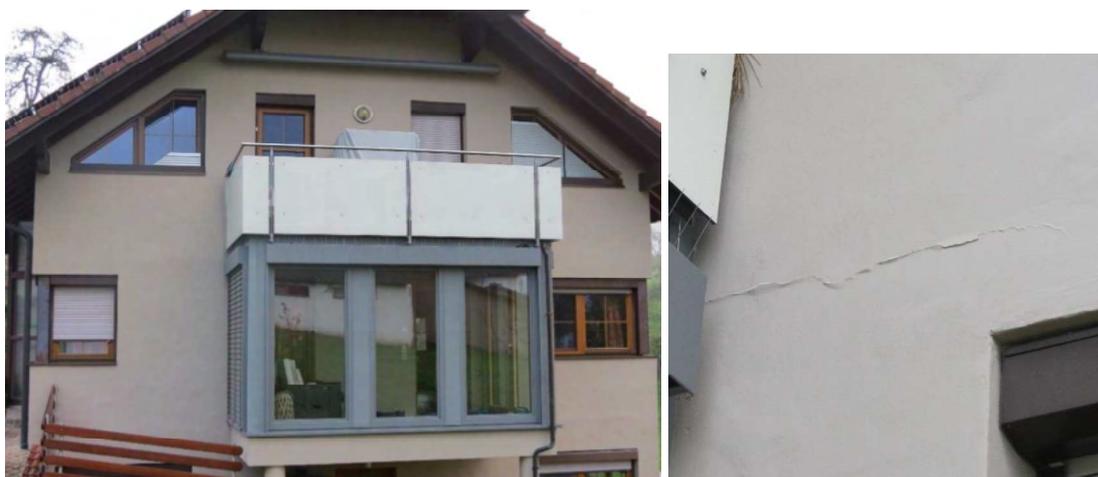
Figure 54:
South view of the façade (left) of object 10. Crack formation visible at the upper connection of the conservatory (right).

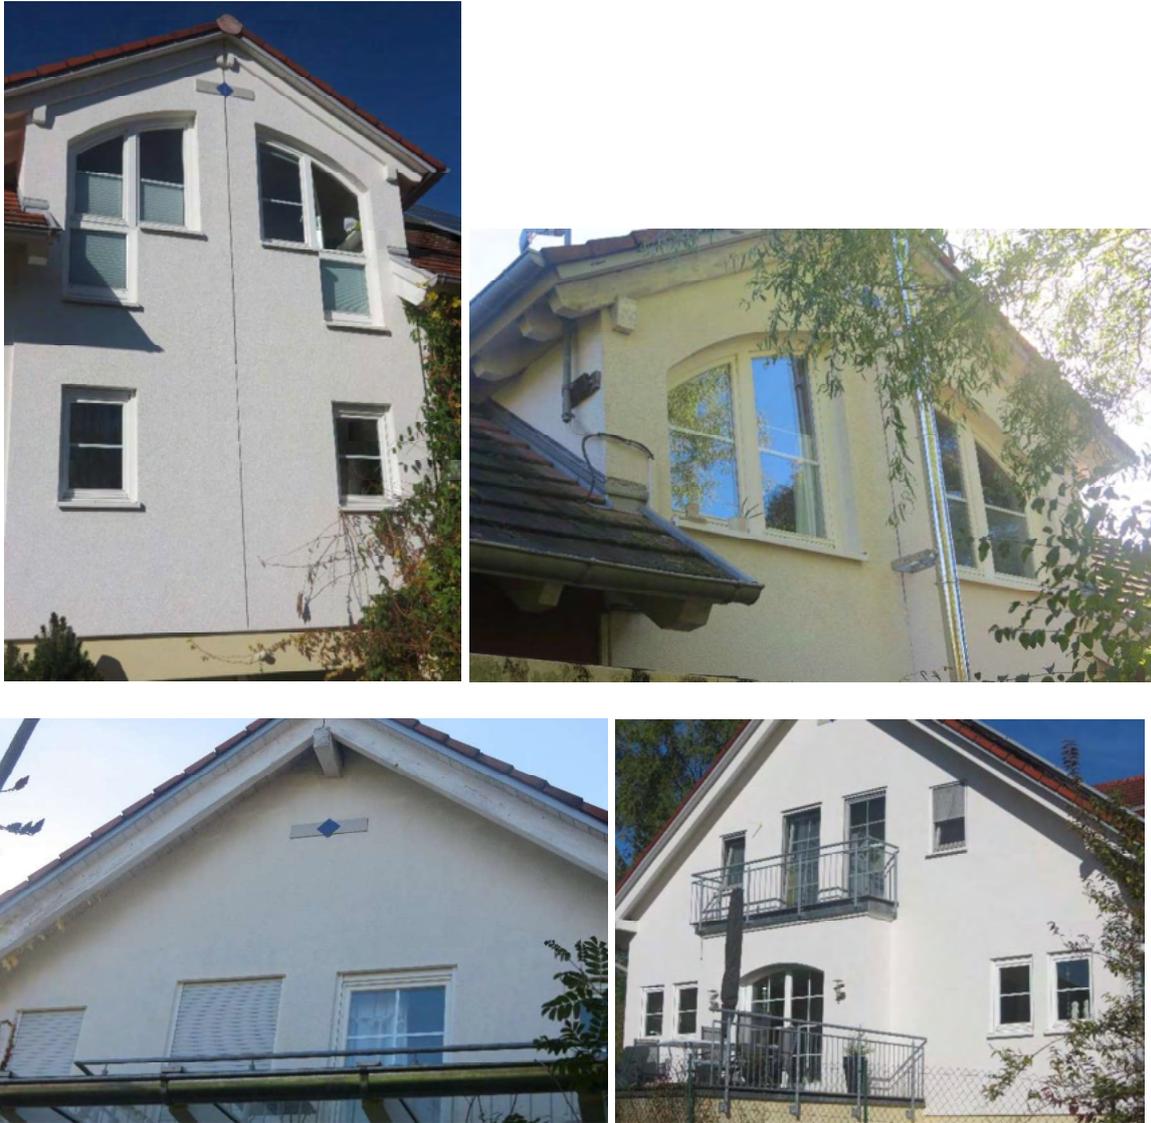
(in original condition). On the east half, a slight green coating was visible, while the west half was bright white. No crack formation, blistering or spalling is visible on any façade.

Figure 57:
Views of the façades of object 13.
Top left: south-east façade - painted in 2020.
Top right: north-west façade - only western half painted in 2020.
Bottom left: north - east façade.
Bottom right: south-west façade - painted in 2020.
