Fraunhofer Institute for Building Physics IBP

IBP report HTB-005EN/2023

Assessment of the long-term reliability of installed external thermal insulation composite systems

Conducted on behalf of
Verband für Dämmsysteme, Putz und Mörtel e.V.
Reinhardtstraße 14
10117 Berlin, Germany

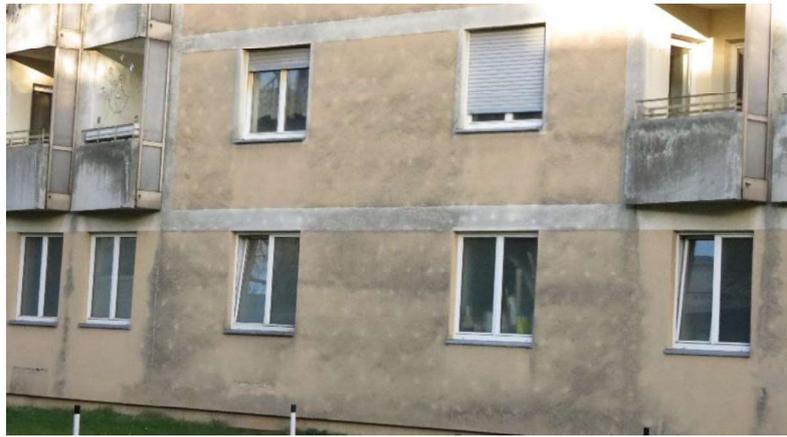
Figure 6:
View of the facade of object 16. With noticeable appearance of the dowels on the first and second floor.

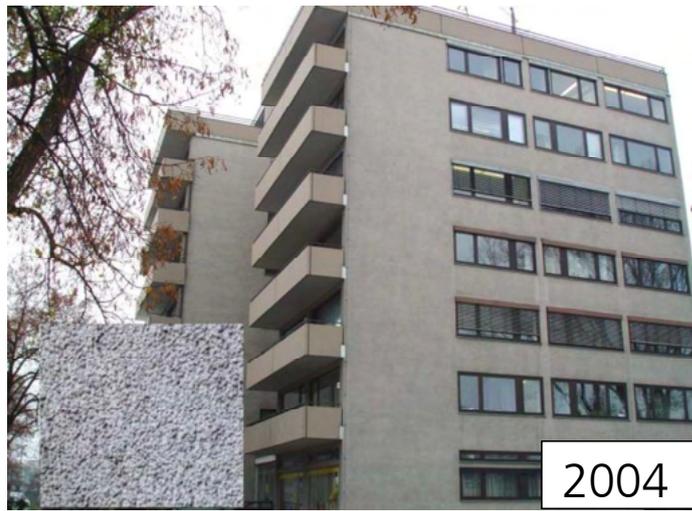
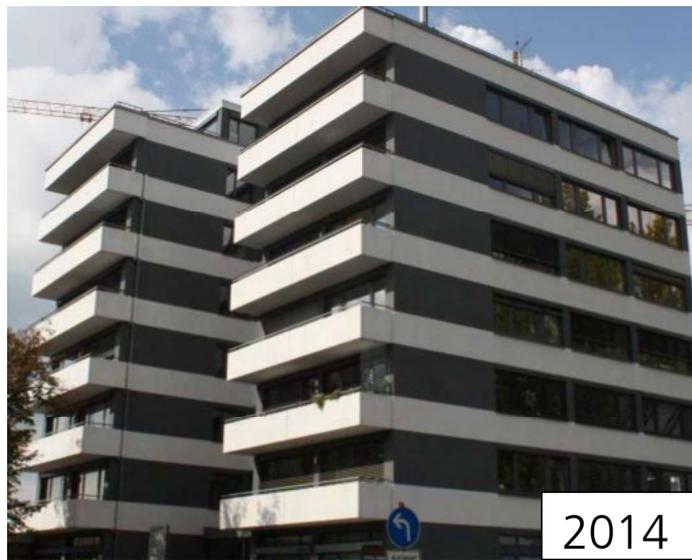
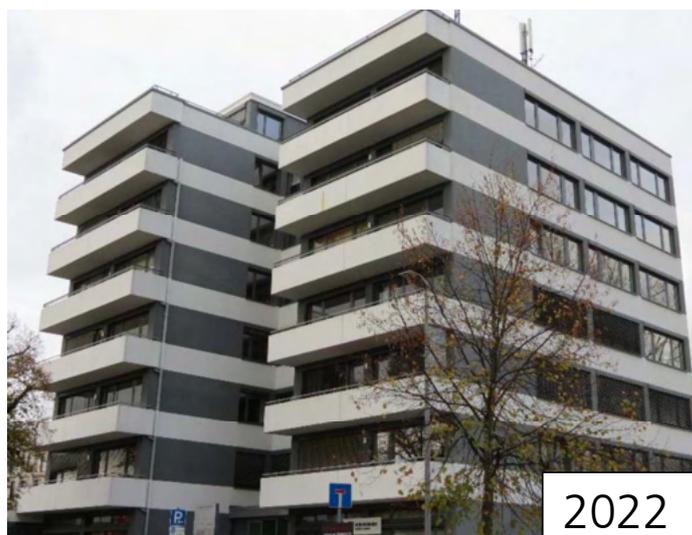
A further building that had not been renovated in the past eight years was object 54 in Neumarkt i. d. Oberpfalz. Figure 18 shows images of the east and south façade in 2004, 2014 and 2022. No significant changes are visible on the south and east façade from a distance. Upon closer inspection, a slight green growth is apparent in the white color strips in some places on the east side as well as a slight blistering in one place. The north side (see Figure 19) of the building shows a strong greening. Here the gray stripes are also green. The thick vegetation on the north side of the building strongly favors the growth of algae on the shaded side. In addition, blisters in the plaster are also visible on the west façade, which is offset to the rear, next to the back entrance (see Figure 20).

Figure 18:
East and south façade (from right) of object 54 in Neumarkt in 2004 (top),
2014 (center) and 2022 (bottom).

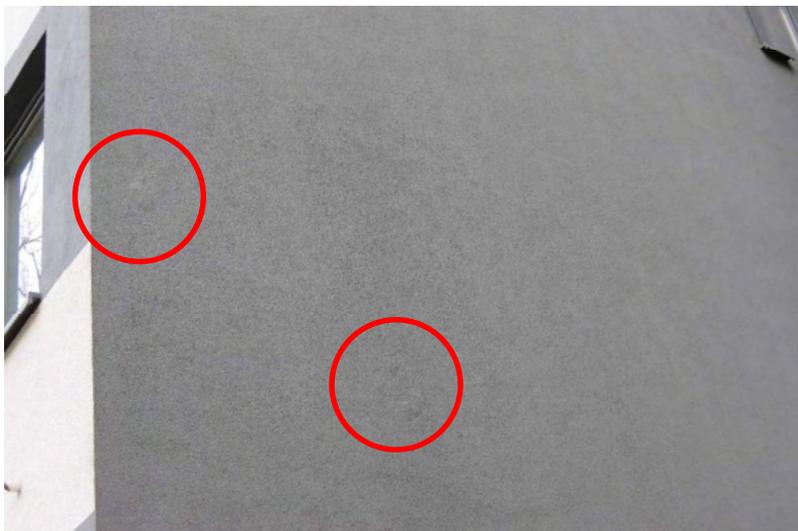
Figure 20:
The west façade, which is offset to the rear, next to the back entrance of object 54 in Neumarkt in 2022 with noticeable blistering.

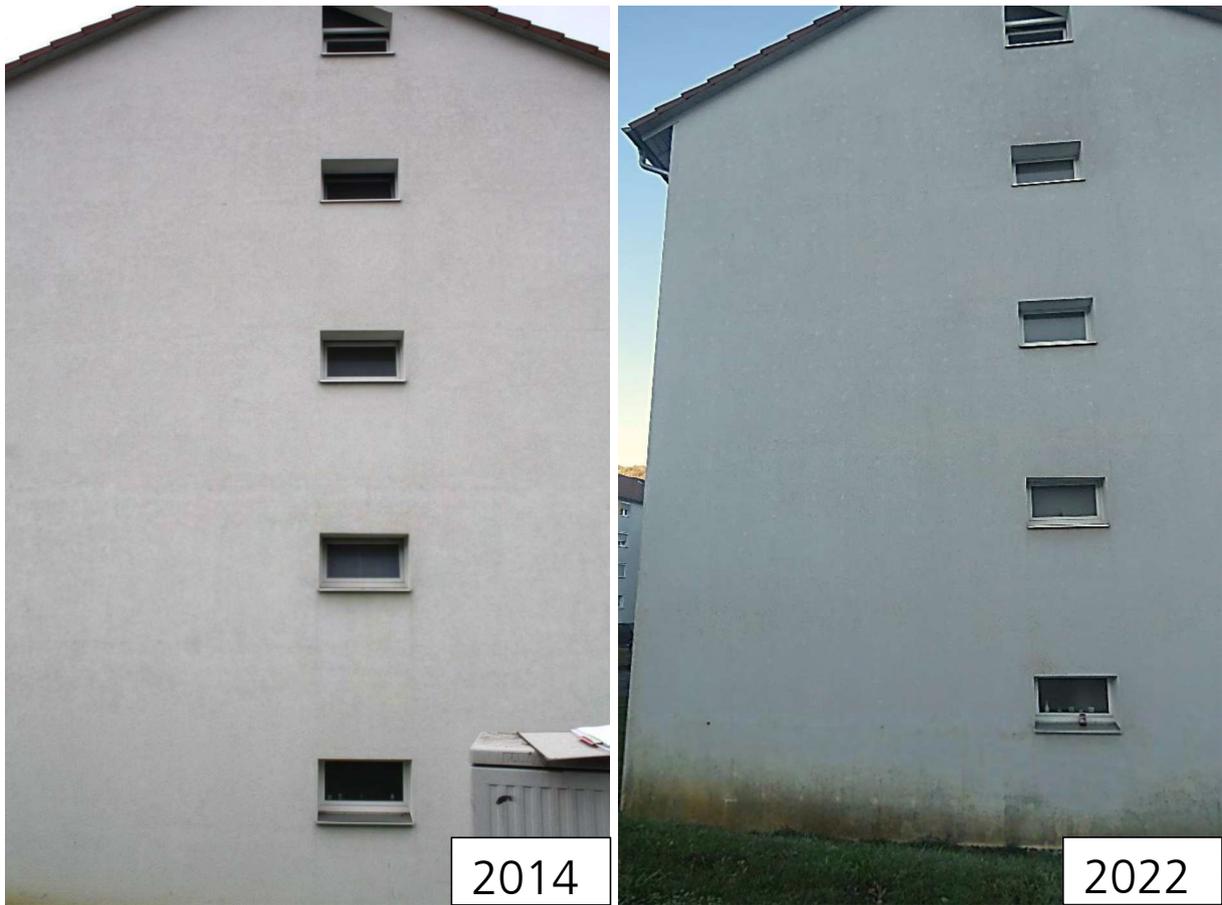
Figure 26:
East view of the façade of object 32, in 2014 (left) and 2022 (right).

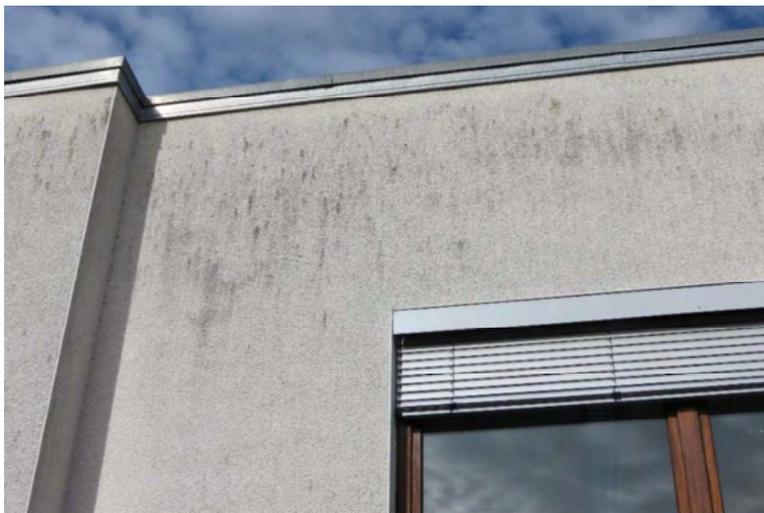
Object 2 is a workshop building that was built in 1973 and insulated in 1986 with 5 cm PUR/PIR insulation and mineral plaster. Since then, the façades have not been renovated anymore. The façade construction was thus 36 years old. No damage is visible over any of the surfaces (see Figure 33). Some damage can be seen only in the base area, although this is likely to have been caused by mechanical influences. Biological growth is also discernible in the lower area of the façade, which is probably due to spray water from the ground. On the south side (Figure 34), noticeable gray areas and condensation trails are visible in the upper façade area.

Figure 34:
View of the upper south facade.

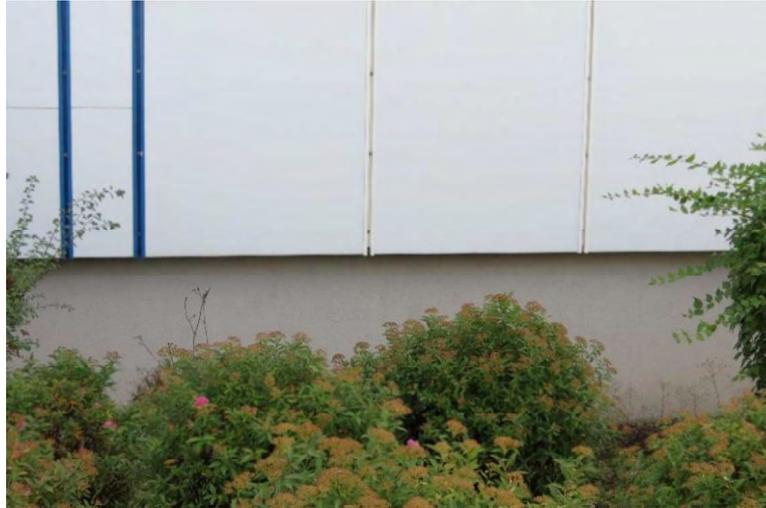
Object 3 is an office building with a base area that was constructed in 1997 with 10 cm of PUR/PIR and a synthetic resin plaster. The façade surfaces on top of this are cladded with façade panels. The assessed surfaces on the north, west and south side of the building (Figure 35 and Figure 36) do not show any biological growth or damage in the base area. Only at the connection of the exterior cellar stairs to the insulated exterior cellar wall (Figure 37 there are significant traces of weathering from rainwater flowing down onto the cellar stairs, but there is no crack formation.

Figure 35:
View of the base area of the north façade, which is insulated with purenotherm.

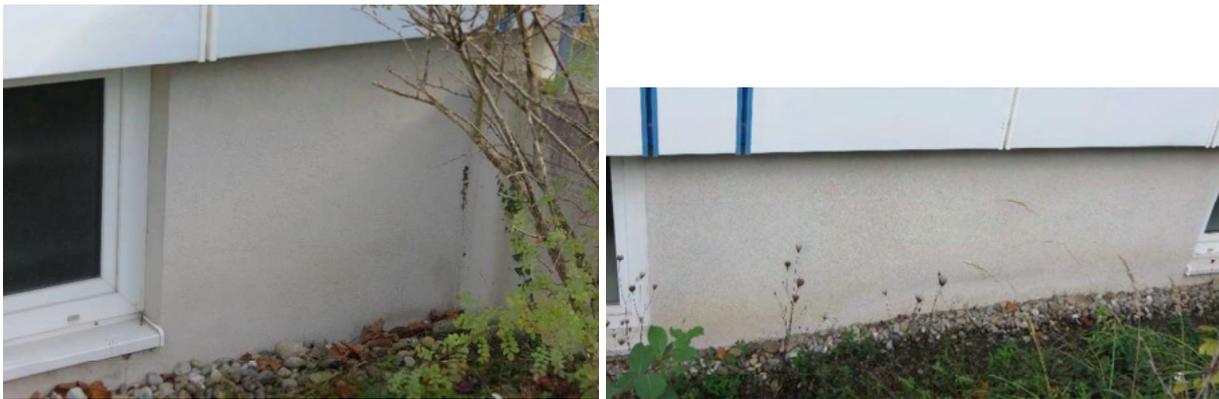
Figure 36:
View of the base area of the west (left) and south (right) façade, which is insulated with purenotherm.

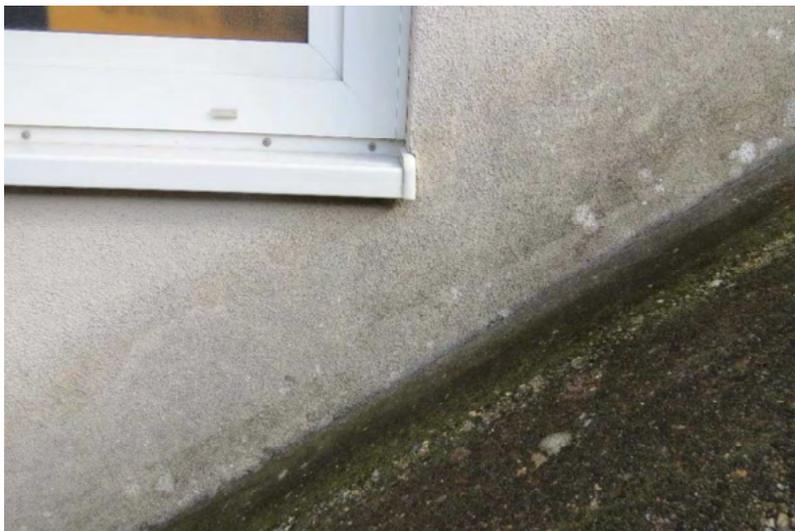
Figure 37:
View of the base area of the west façade at the stairs going down, which is insulated with purenotherm.

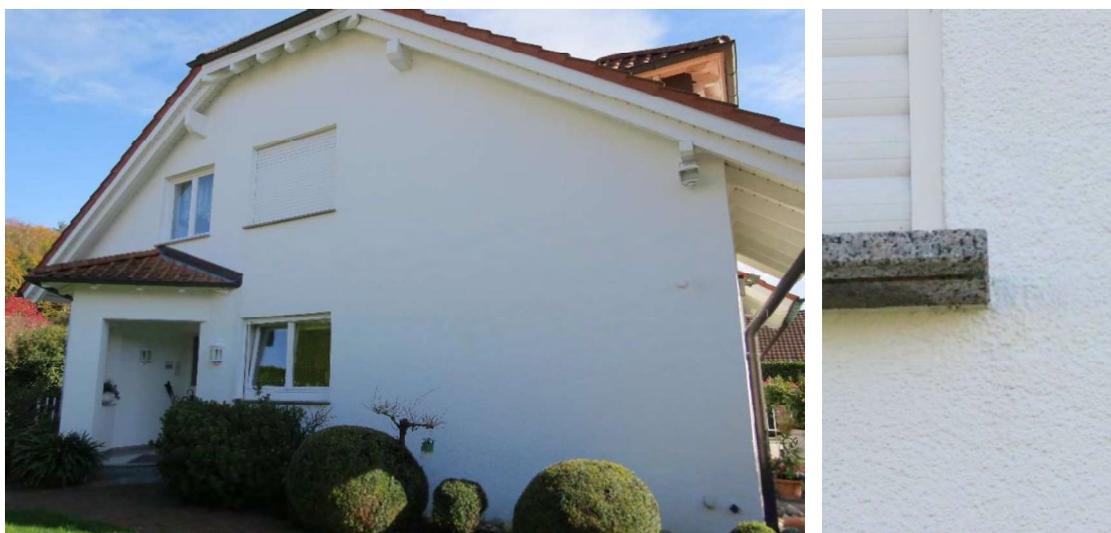
Object 4 is another building with PUR/PIR insulation. This house was built in 1991 and constructed with 8 cm ETICS and synthetic resin plaster. The façades have been painted over once. Figure 38 and Figure 39 show the west and north façade including a windowsill connection. It can be seen here that the façades are in perfect condition. There are no objectionable cracks or graying.

Figure 38:
View of the west façade (left) and a windowsill connection (right) of object 4.

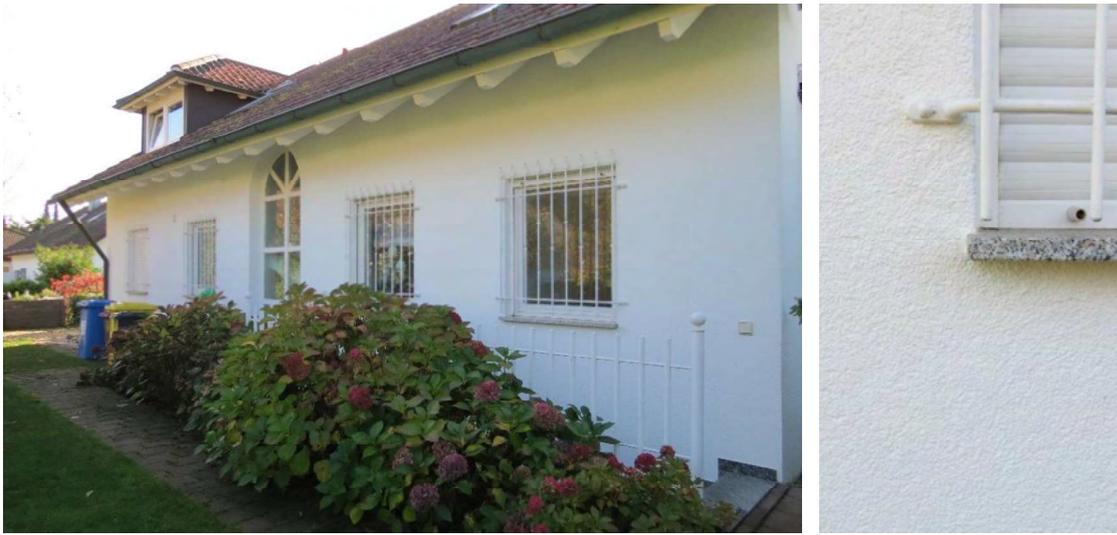
Figure 39:
View of the north façade (left) and a windowsill connection (right) of object 4.

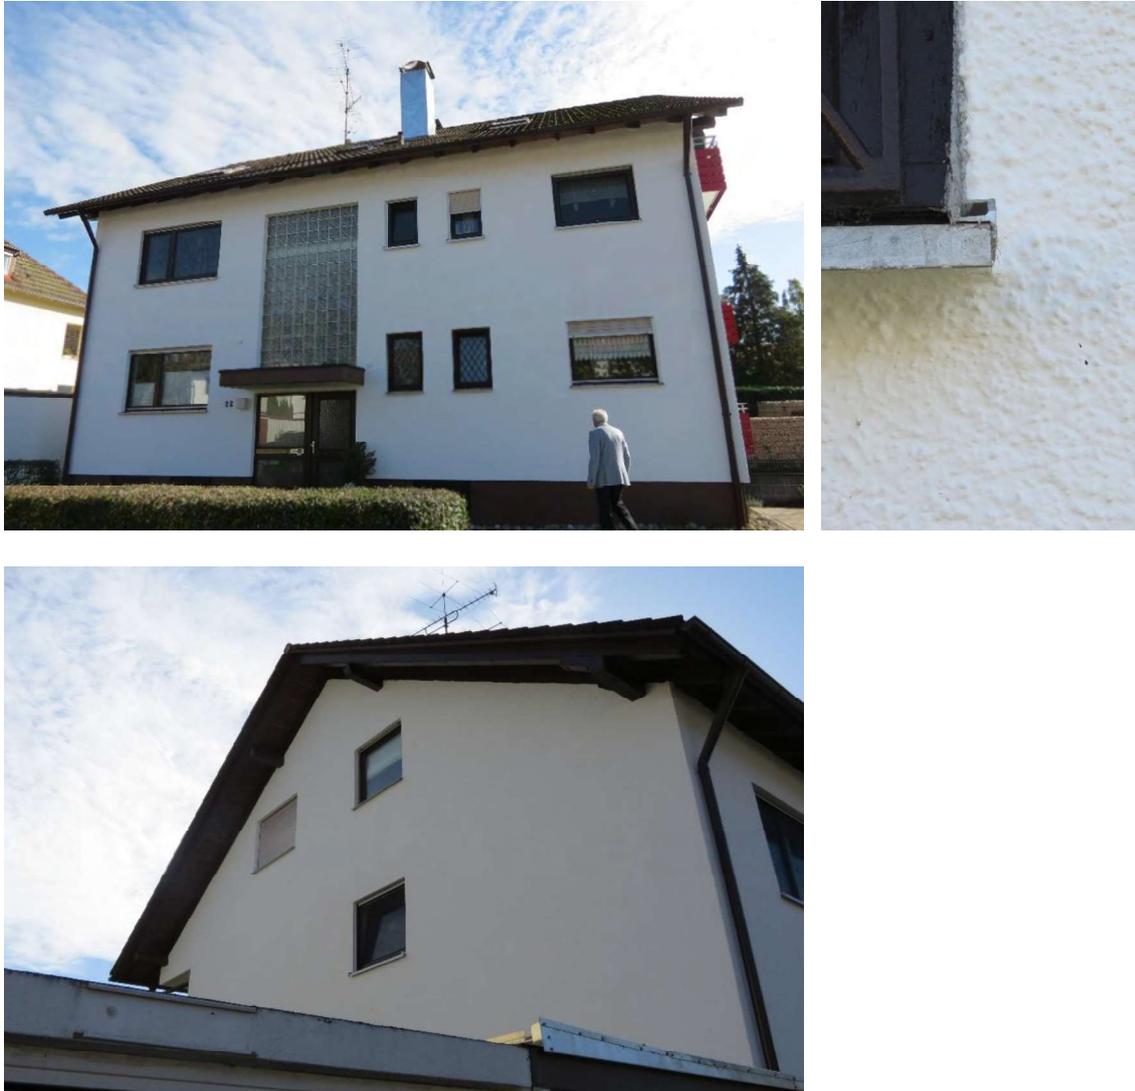
Object 11 was built in 1979/1980 and insulated with an ETICS made of 8 cm PUR/PIR panels. The façades had been painted twice since the building was constructed. The condition of the façades was perfect and free of damage. Views of the west and north façades can be seen in Figure 40.

Figure 40:
View of object 11 of the west (top left) and north façade (bottom) as well as a windowsill connection on the west side (top right).

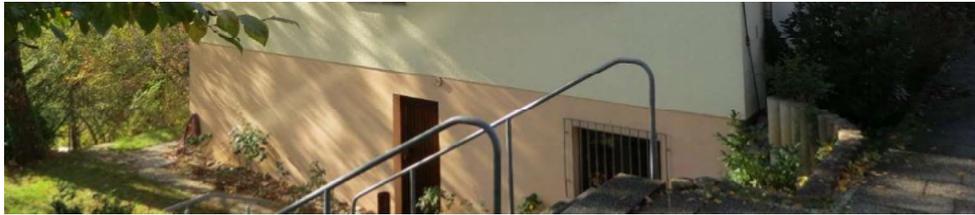
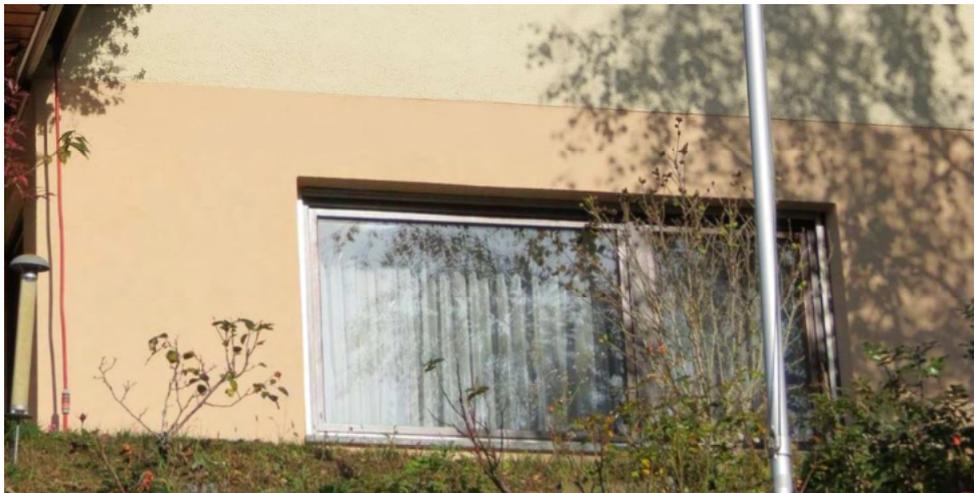
Object 5 is another building with partial insulation. It is a town house built on a slope, and only its east side and its south side on the first floor are insulated with PUR/PIR. Unfortunately, neither the age nor the thickness of the system is known. As can be seen in Figure 41 (orange areas), there is no damage or graying or biological growth on the surfaces.

Figure 41:
View of the east (top) and south façade (bottom) of object 5.

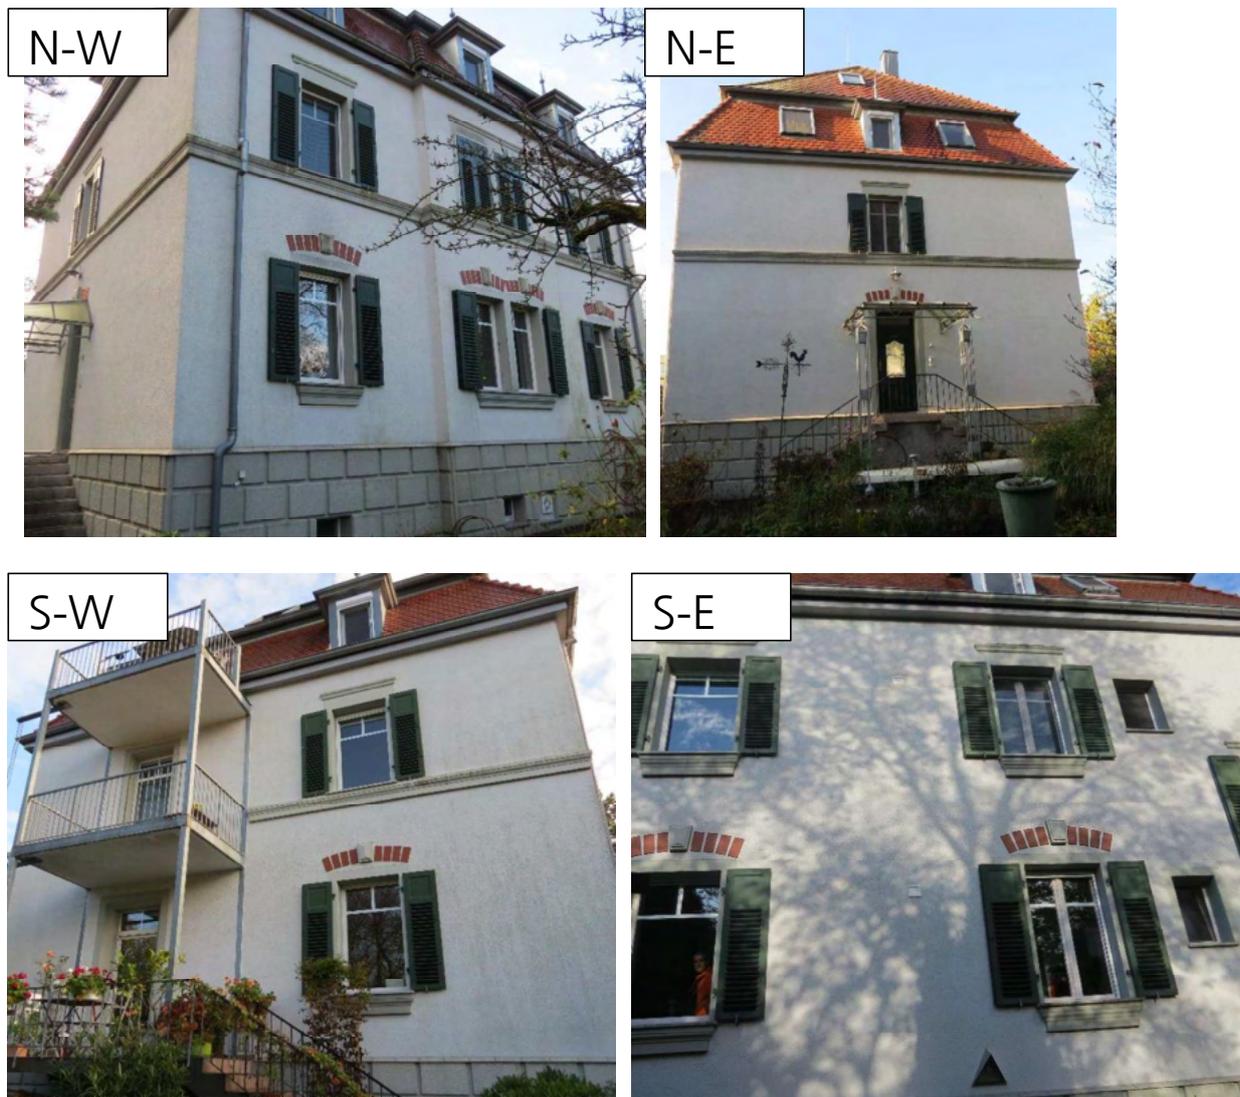
Object 6 is a building that was already built in 1903. In the period of 1996–1998, the façades were completely renovated by removing the old plaster and the cement asbestos panels from the 1960s and replacing them with an ETICS, consisting of 8 cm PUR/PIR panels (without dowels) and a mineral plaster system as well as a silicate coating. During the renovation, façade profiles were applied to restore the original appearance of the house from 1903. Since 1998 there had been no further work on the façades. The façades (Figure 42 to Figure 44) of the house were completely damage-free after 24 years. No cracks, blistering or spalling can be seen. Algae growth and significant graying are visible above all on the north-west and south-west façade of the building. The thick greenery around the house slightly increases the risk of microbial growth on the façades. In addition, growth is visible on the façade profiles and in the connection area of the exterior stairs and the façade, which can be encouraged by spray water in these areas.

Figure 42:
View of all four facades of object 6. The building is at a 45° angle to the main orientation. The views are as follows:
Top left: north-west façade.
Top right: north-east façade.
Bottom left south-west façade.
Bottom right: south-east façade.

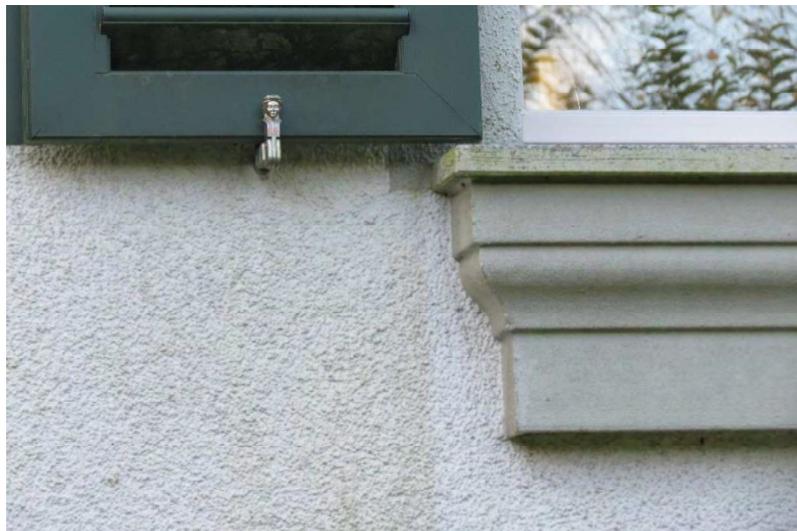
Figure 44:
Close-up of a window connection with a frieze on the NW façade.

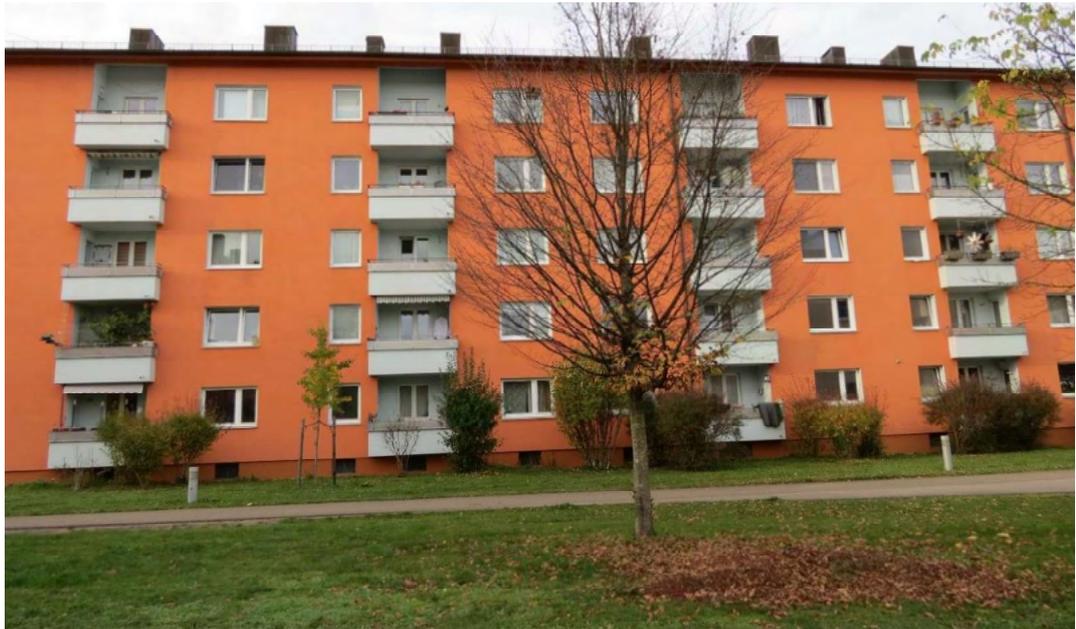
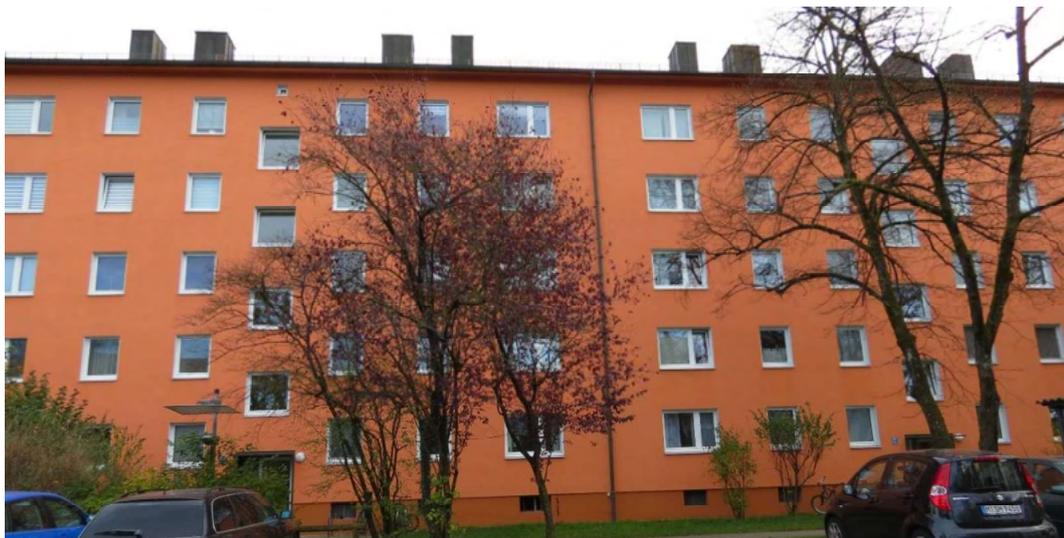
Figure 45:
North (bottom) and south view (top) of the house numbers 67–69.

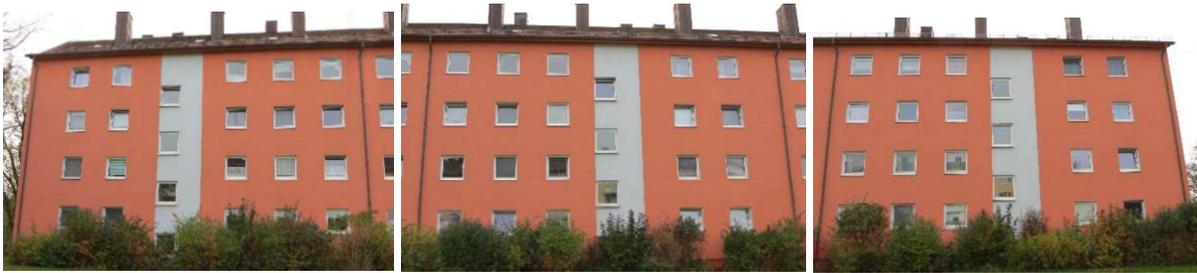
Figure 46:
East views of the housing block house numbers 73–77.

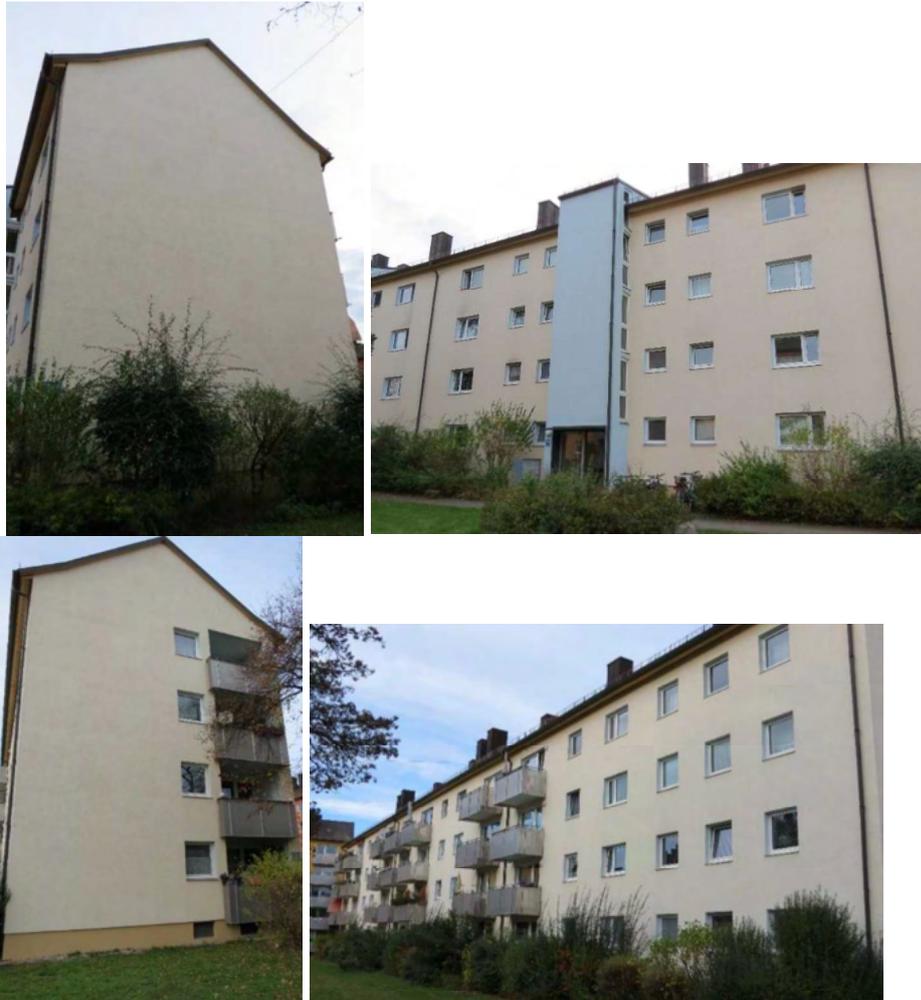
Figure 47:
Views of the facades of house numbers 79–83.
Top left: north façade.
Top right: east façade.
Bottom left: south façade.
Bottom right: west façade.

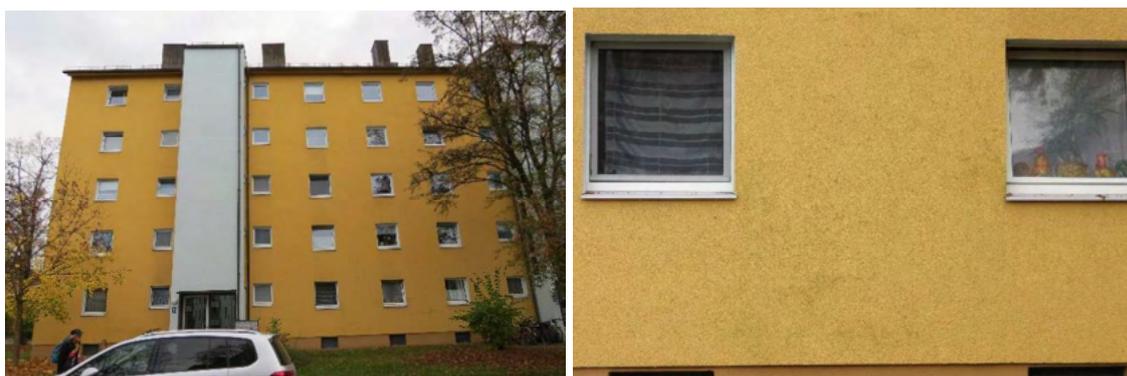
Object 7 consists of four large housing blocks with five stories each (Figure 45 to Figure 49), which were all renovated at the same time. All the buildings were equipped with an ETICS consisting of a 6 cm layer of mineral wool and a 2.5 cm thick layer of plaster in 1987–1988. A renewal coating of silicone resin paint was applied in 2009. The only difference between the buildings is the paint and sometimes the orientation of the building. No crack formation, blistering or spalling of the plaster is visible on any of the buildings. Only on the east side of house number 85 (yellow façade) is there a slight green growth visible on the lower north-east half of the façade, as evident in Figure 48, as well as in a small area on the north side on the first floor (Figure 49).

Figure 49:
View of the north façade of house number 85, including a close-up of the lower façade surface with algae growth.

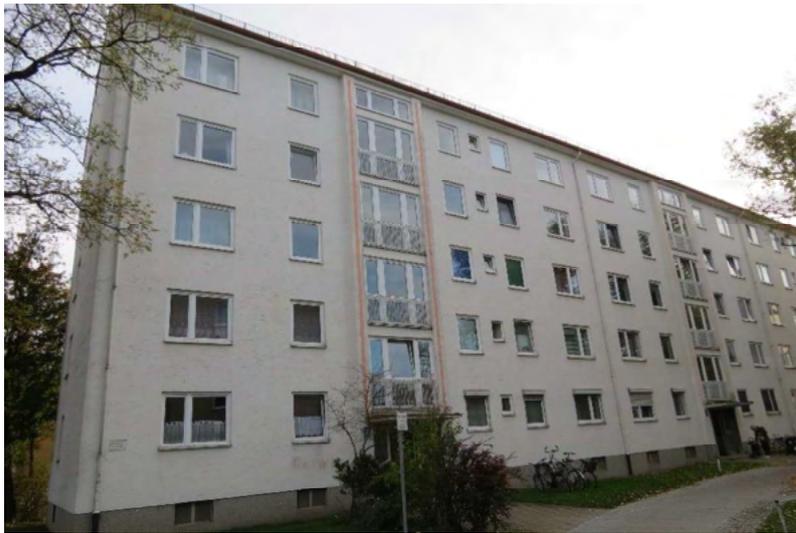
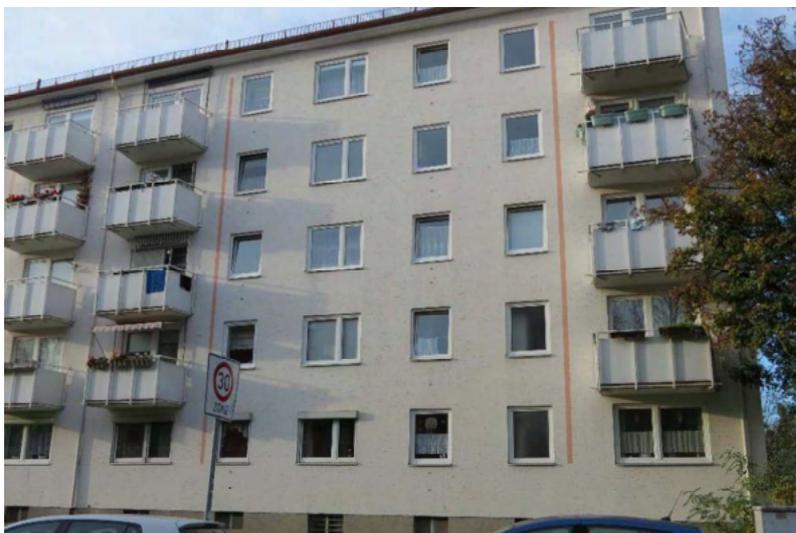
Object 8 (Figure 50) was added to the assessment list; however, upon inspection of the building, it turned out that the building did not have any ETICS yet. Unfortunately, there was no further information on whether and when a new coat of paint was applied to the façade. Optically, there are no irregularities.

Figure 50:
View of the north (top) and south façade (bottom) of object 8.

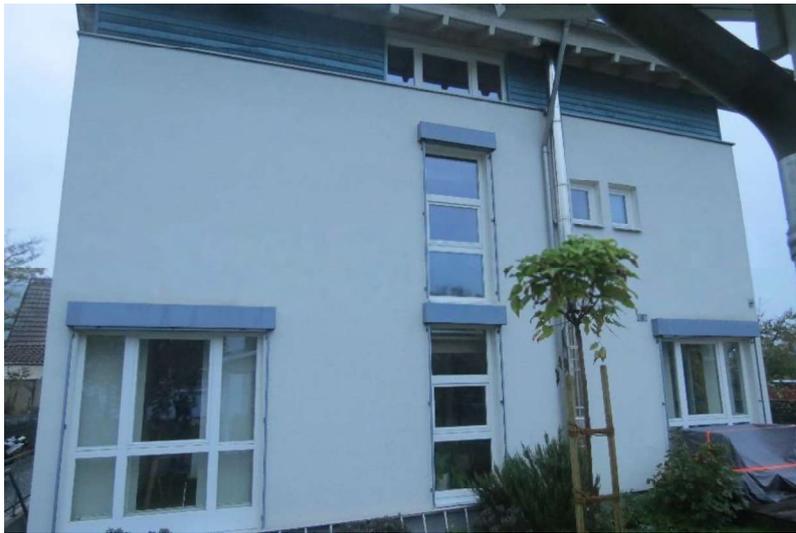
Object 9 is a duplex house where the west side of the building was assessed. The house was built in 1998, insulated with 6 cm wood fiber panels and plastered. The south-west side (Figure 51) of the building shows a slight graying without any features. In the middle of the duplex house, a section of the façade is offset towards the rear. On the south side (Figure 52), the fastening dowels of the ETICS panels appear directly underneath the roof overhang; significant graying of the surface is also visible. On the northwest side, a canopy is mounted in the recess of the building. In the area of the center fastening of the steel construction (Figure 53), cracks have formed over the plaster, which are related to the load transfer of the structure, though. Otherwise, no cracks are visible on any of the three house façade surfaces.

Figure 51:
View of the south-west façade of object 9.

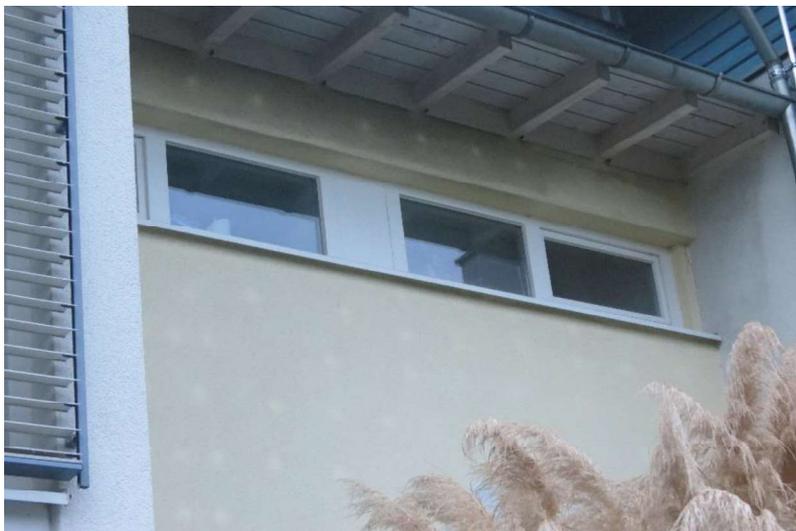
Figure 52:
View of the south-east façade of object 9, which is offset to the rear.

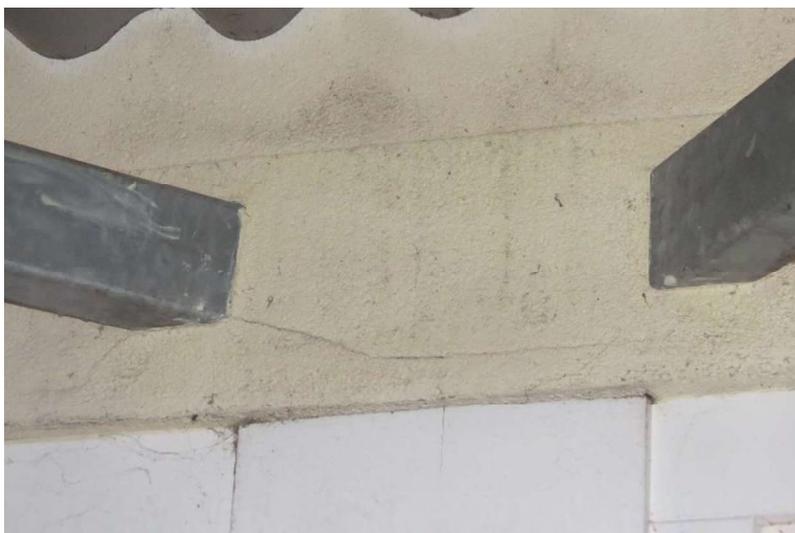
Figure 53:
Connection detail of the canopy on the north-west side of object 9.

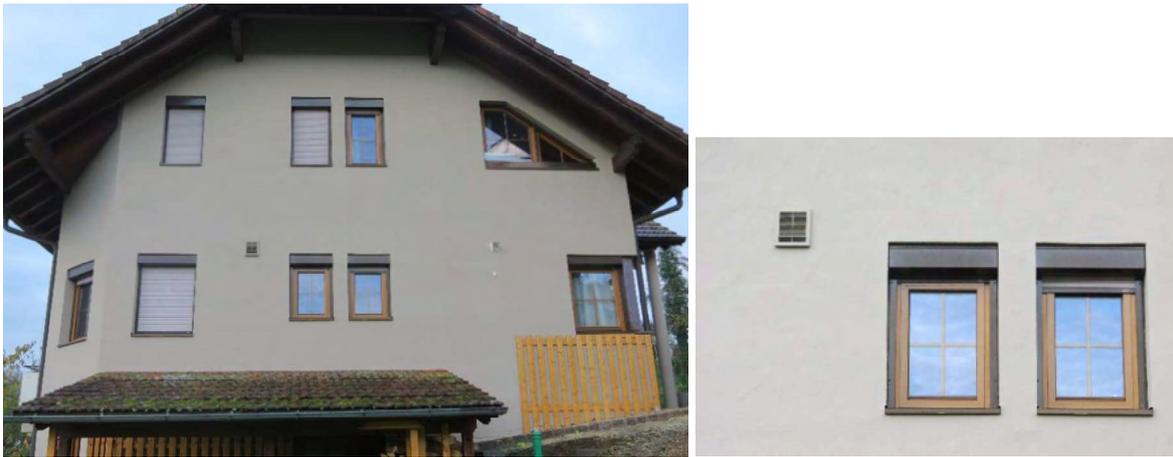
Figure 55:
View of the north façade of object 9 with close-up of the ventilation opening next to the windows.

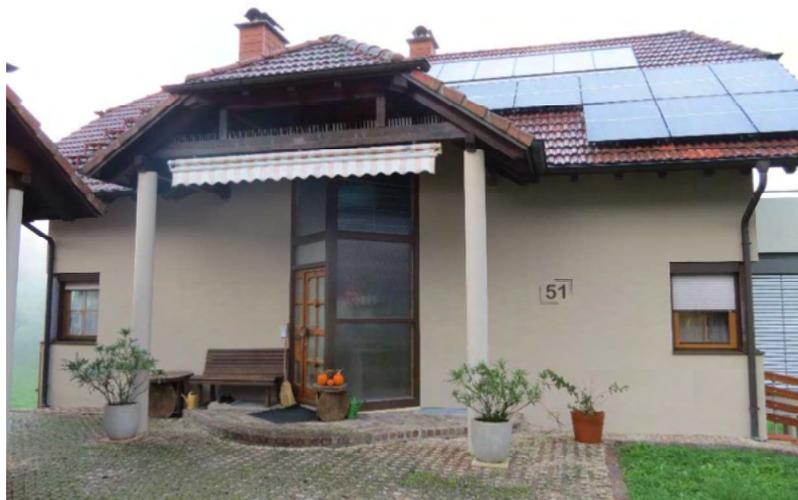
Figure 56:
View of the west façade of object 9
